D.M. MacKENZIE, SHERIFF PLACE, HAMILTON

REPORT ON LAND STABILITY OF LOTS 1 to 9

OF PROPOSED SUBDIVISION OF PTS LOTS 1 & 6

DP14466 and LOT 1 DPS 19850

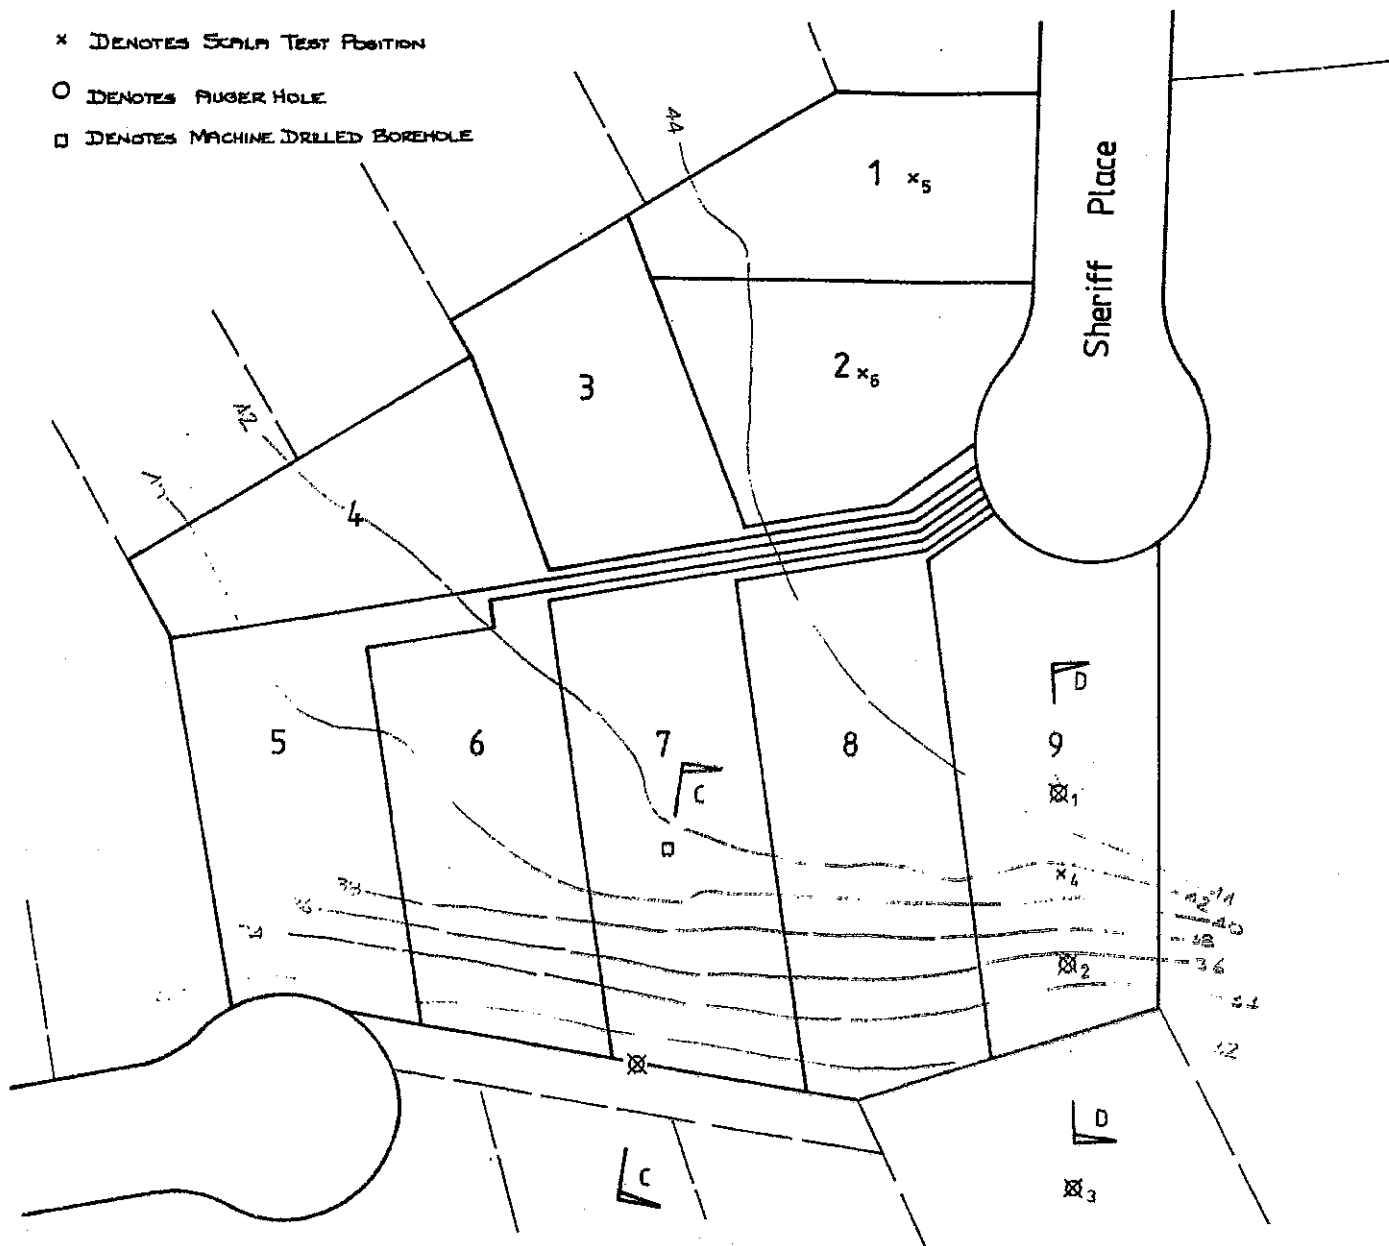
STABILITY INVESTIGATION
SITE PLAN
FIGURE 1

The proposed subdivision scheme plan F1381 dated August 1984 as prepared by Thomson and Farrer is reproduced in this report as Figure 1. It shows the location of cross-sections C & D, being slope profiles surveyed by Thomson & Farrer on Lots 7 & 9. These profiles are reproduced on Figures 2 and 3 respectively.

The field work comprised the drilling of 3 boreholes by hand auger, one each at the top, the middle and the bottom of the slope on Lot 9 and located on cross-section D, as shown on Figure 1. A Scala penetrometer test was carried out adjacent to each borehole and also at positions 4,5 & 6 as shown on Figure 1.

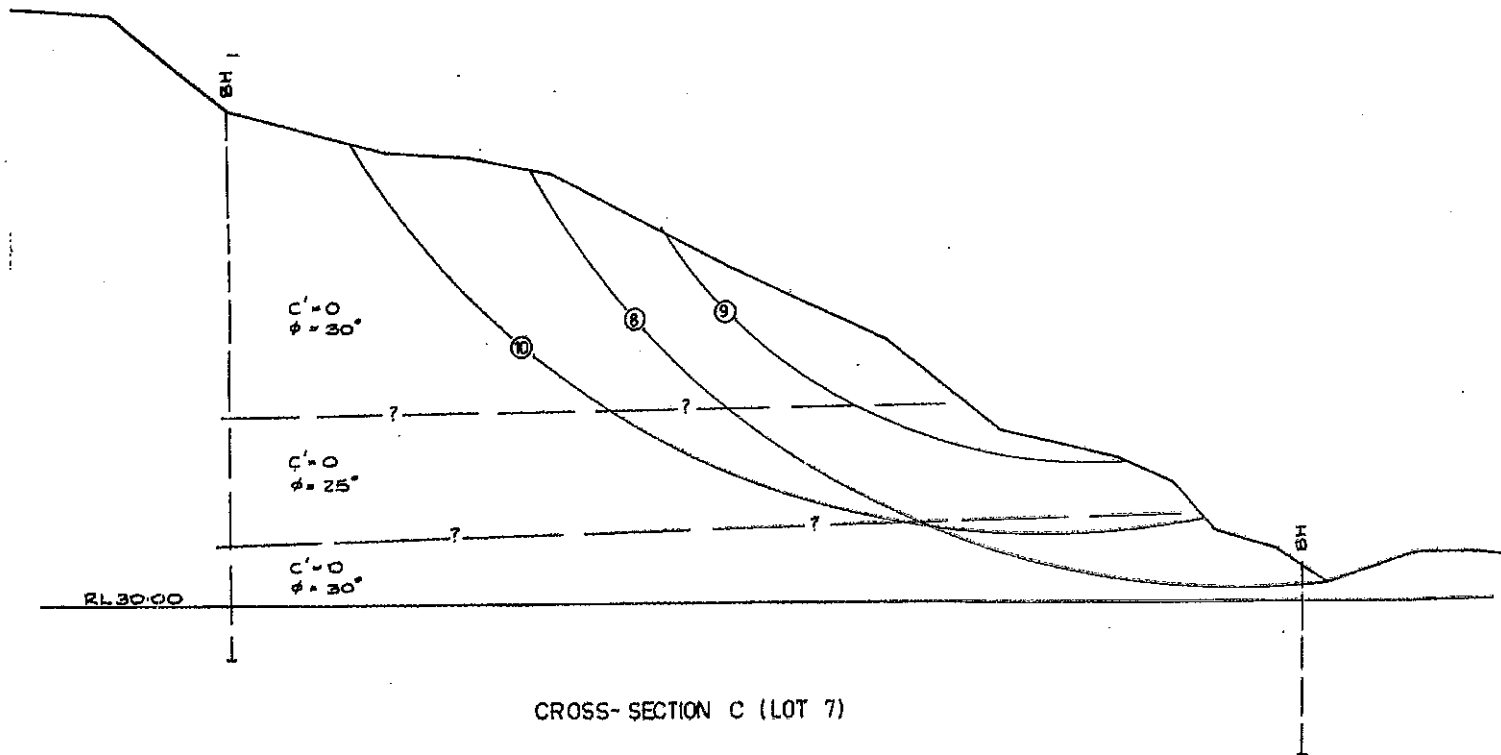
LAND STABILITY
FIGURE 2

The stability of cross-section C was analysed in the previous investigations (ref. Worley Report No. 006184 dated February 1983), using the Bishop Modified Method. Figure 2 of this present report is reproduced from the previous work and shows the assumed distribution of soils in terms of strength parameters as derived from the investigation data, and also the three trial circular failure arcs analysed (nos. 8, 9 & 10). The calculated factors of safety under static loading conditions are 1.46, 1.33 and 1.66 for arc nos. 8, 9 & 10 respectively.

The stability of both cross-sections was re-analysed assuming that the slope face has been re-graded (flattened) to a constant angle of 25° and using soil strength parameters of cohesion $C' = 0$ kPa and $\phi' = 34^\circ$. In addition to the static analysis, a pseudo-static seismic analysis was carried out to give an indication of the safety of the slope under earthquake loadings with a horizontal ground acceleration of $0.125g$. The factors of safety for the re-graded slope profile are:

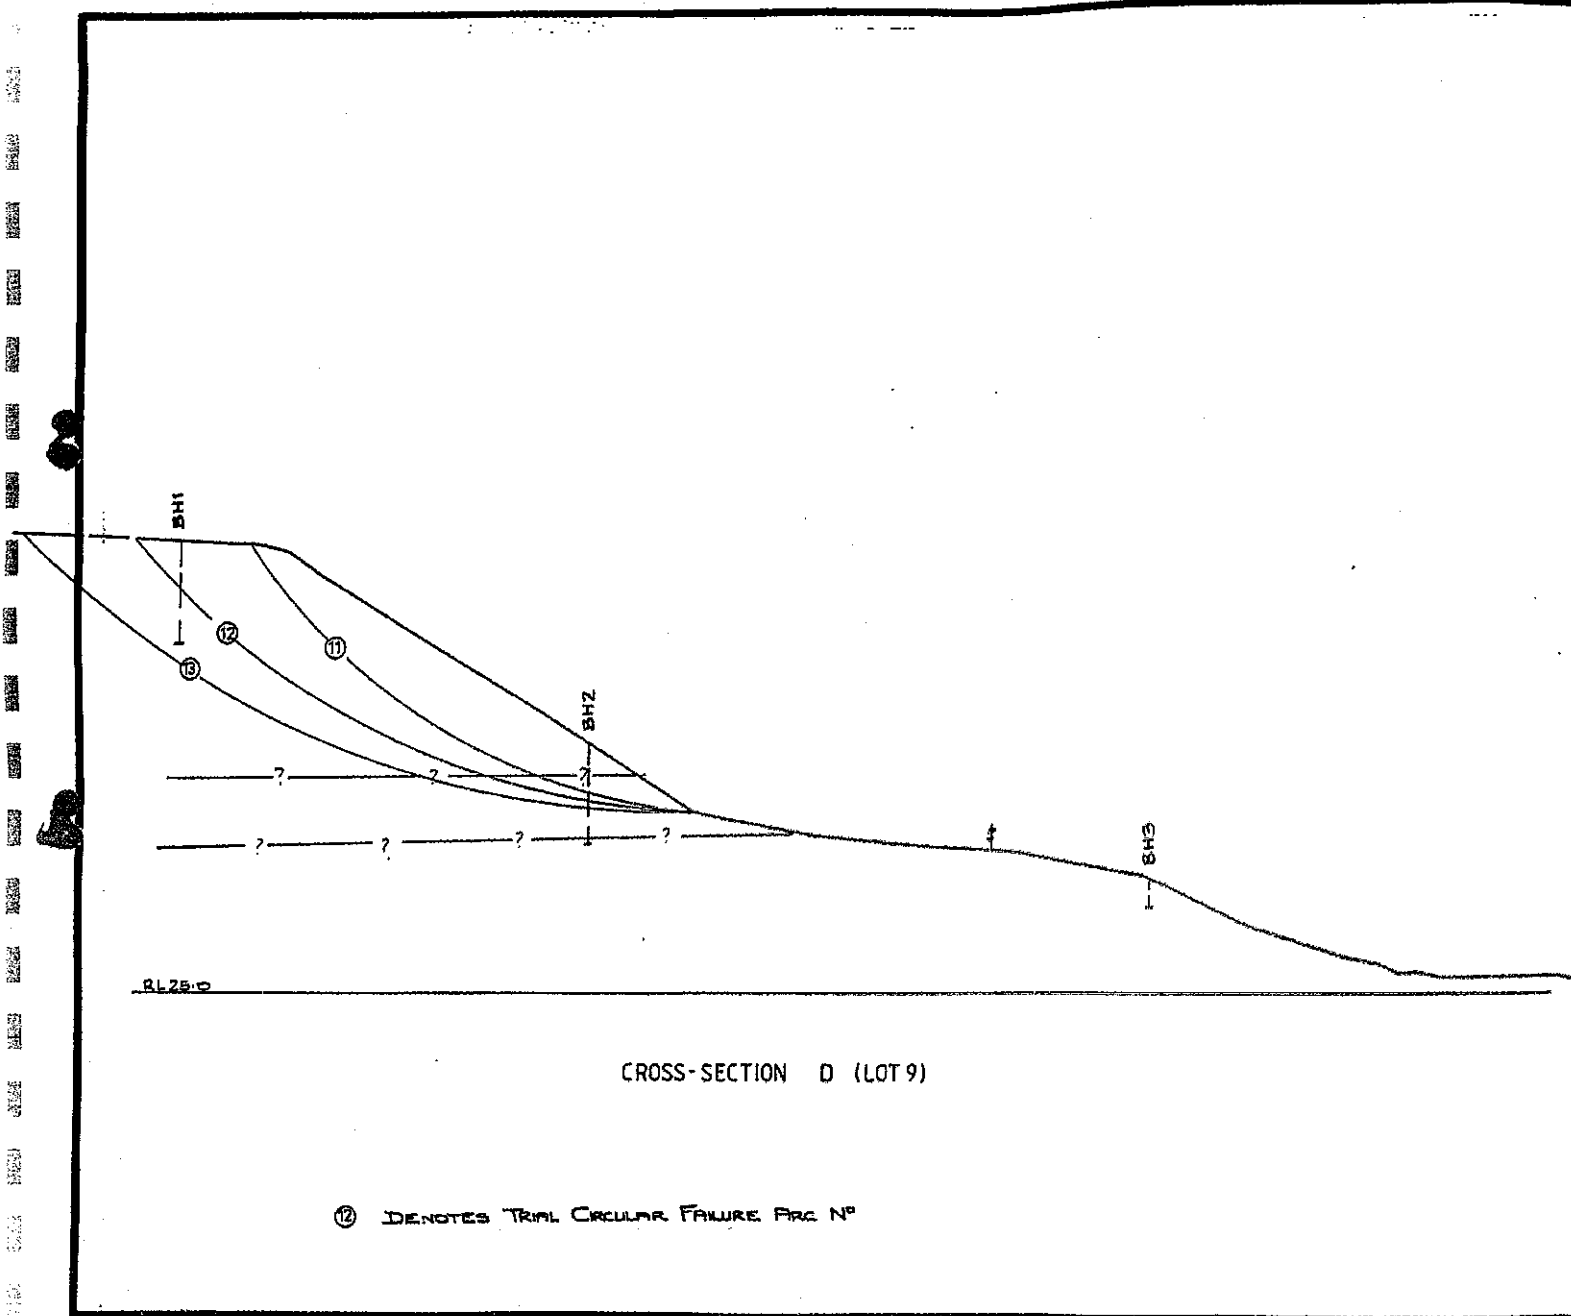
WORLEY CONSULTANTS LIMITED CONSULTING ENGINEERS SURVEYORS GEOLOGISTS & PLANNERS			
THOMSON & FARRER MACKENZIE SUBDIVN SHERIFF PLACE HAMILTON			
SHEET TITLE			
LAND STABILITY			
FIGURE 3

The stability of cross-section D has now been analysed on the same basis as for cross-section C. The same distribution of soil strengths as for cross-section C has been used and three trial circular failure arcs analysed are presented on Figure 3. The calculated factors of safety under static loading conditions are 1.22, 1.44 and 1.65 for arc nos. 11, 12 & 13 respectively.

However, on the basis of the existing stability of cross-section D, higher soil strength parameters are justified. The steep portion of the slope profile is shown to have a fairly constant gradient of 32.5° , and assuming that this slope has only marginal stability (say, a factor of safety of 1.05) and that the soils have zero cohesion, the "back-analysis" of this slope yields an average soil parameter of angle of internal friction $\phi' = 34^\circ$. Analysis of arc nos. 11, 12 & 13 using $\phi' = 34^\circ$ gives the increased factors of safety of 1.47, 1.68 and 1.95 respectively.

For residential developments it is considered that a minimum factor of safety against shear failure of a slope should be 1.5, under static loading conditions. Cross-sections C & D do not meet this criterion, although for cross-section D analysed using the back-analysed parameter, the factor of safety for arc no. 11 is only slightly less than this criterion, while the minimum requirement is exceeded for arc nos 12 & 13. Notwithstanding this, it is clear that some remedial work to the slope is required to achieve adequate stability.
