Geotechnical Retrospective Investigative Report

Project Address: 23 Holloway Place, Forest Lake, Hamilton

Reference: 34807103

Date: 7-Jul-25

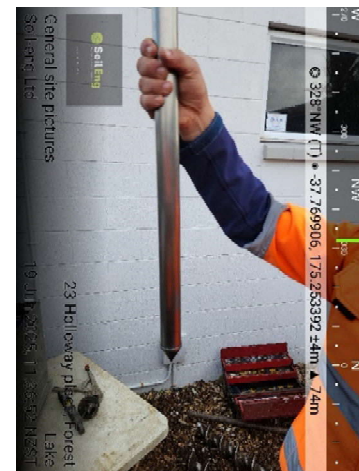
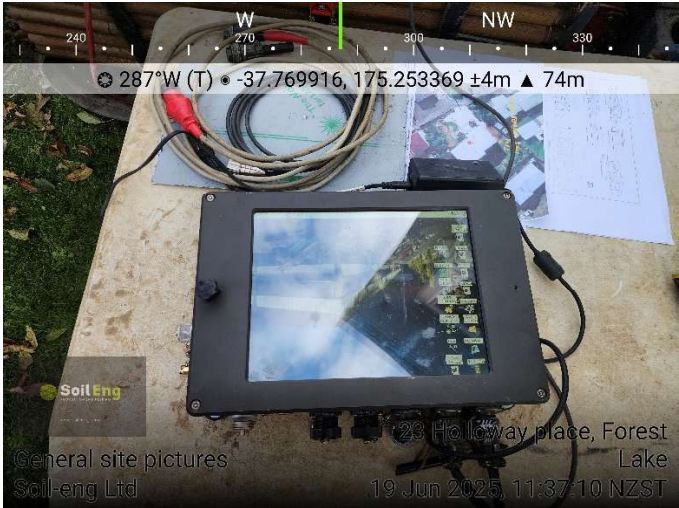
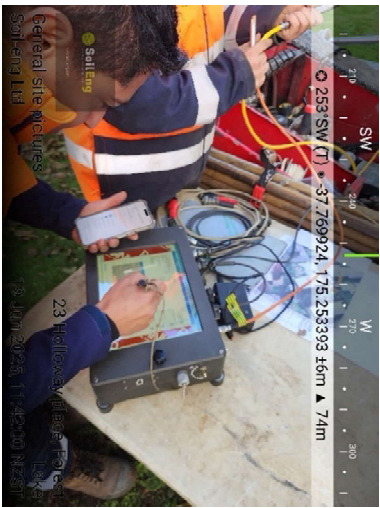
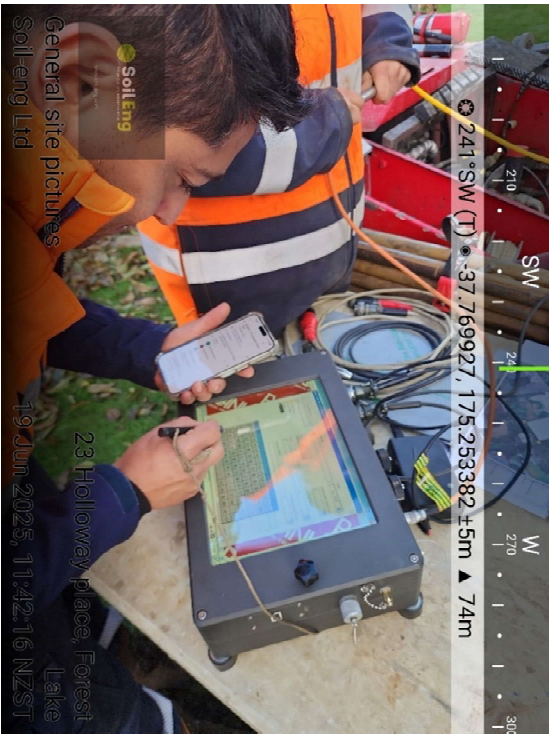
The Magnetometer investigation confirmed that the pile depth is constructed to a depth of 4m. The wooden deck, in front of the house, was also founded at a depth of about 4m, which confirms that the stable ground is found at this depth. The wooden deck plans and design are presented in **Appendix C**.

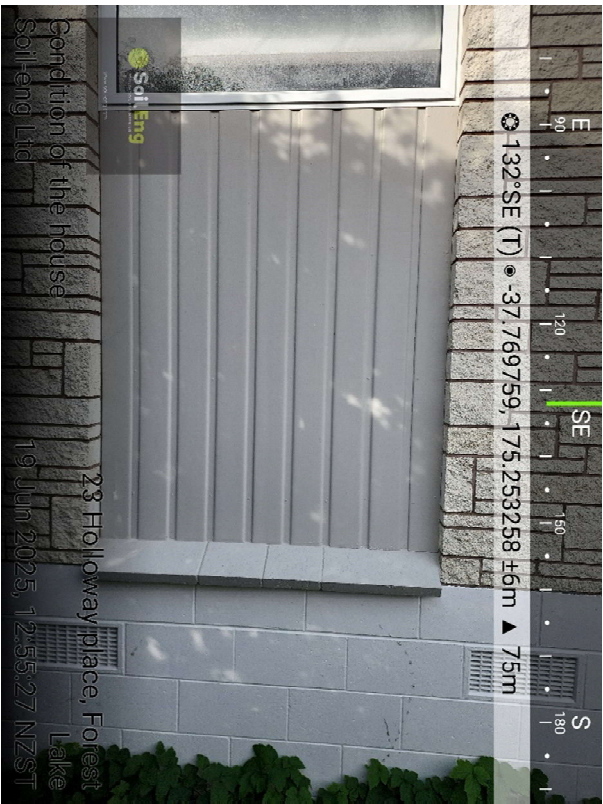
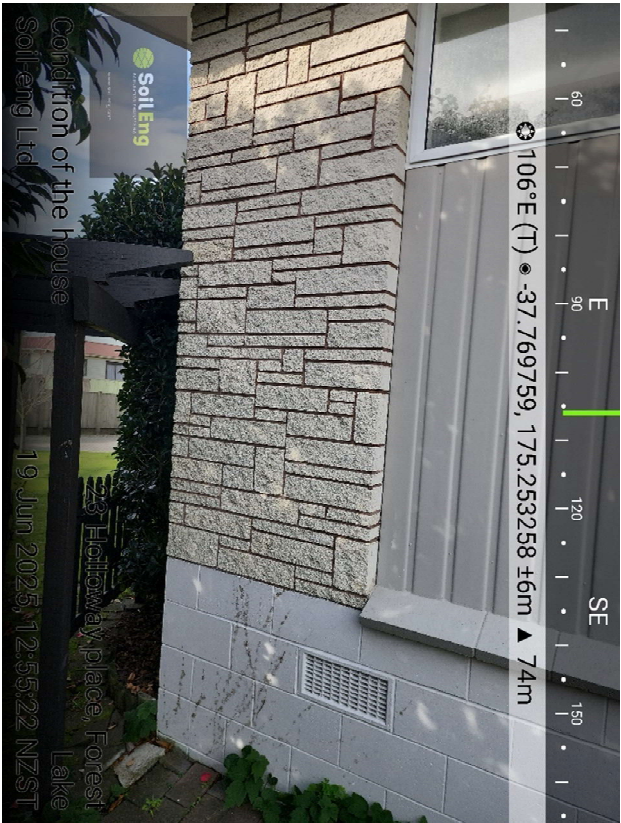
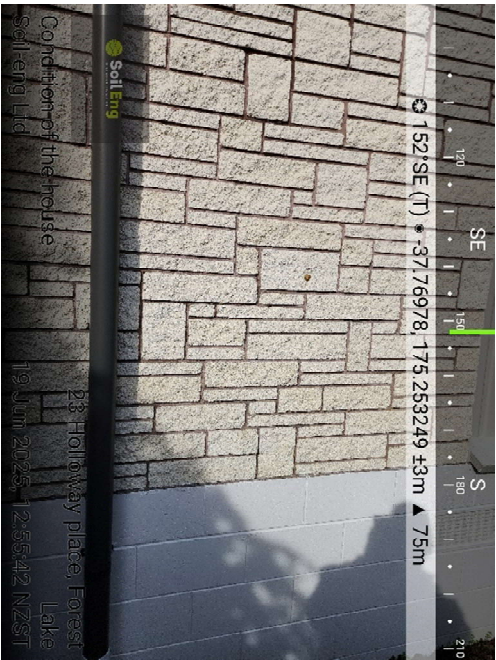
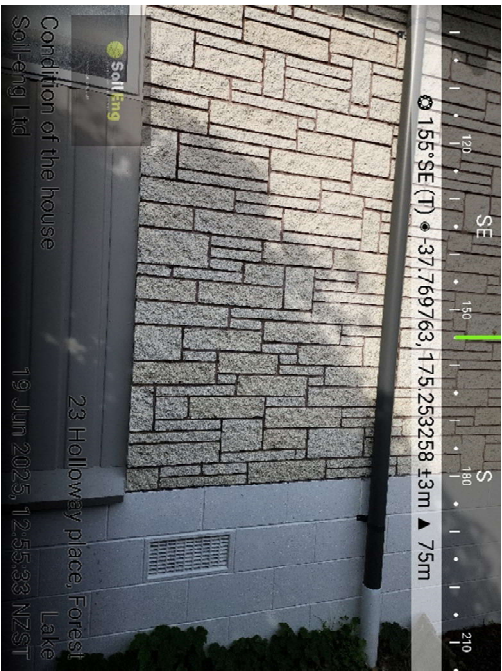
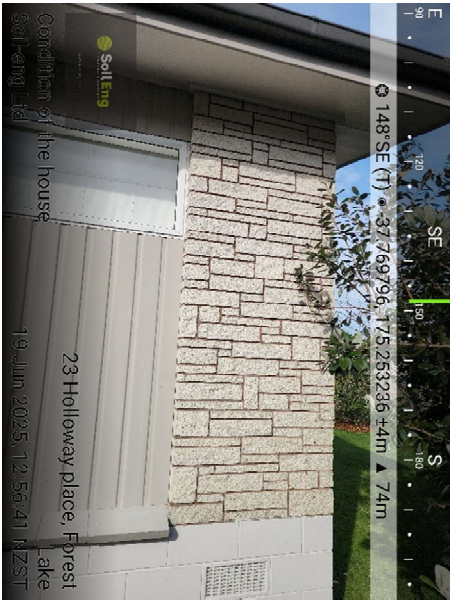
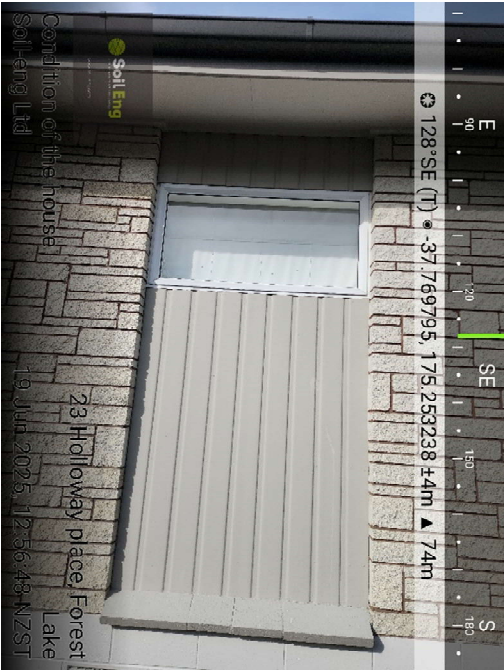
Condition of the house
Soil-eng Ltd
23 Holloway place, Forest Lake
19 Jun 2025, 12:54:56 NZST

To put the above in perspective, the soil that supports the bottom of the piles and the house can provide three times more resistance than what is required. This is further confirmed by our visual inspection of the house exterior and not finding any indications that the house is currently under foundation stress. Also, see our photo file.
