TRANSFERRABLE PRE-SALE INSPECTION REPORT

6c & 6d Edgecumbe Street, Whitiara, Hamilton, 3200

Date of Inspection: 4/11/2025 Time: 12:00 PM

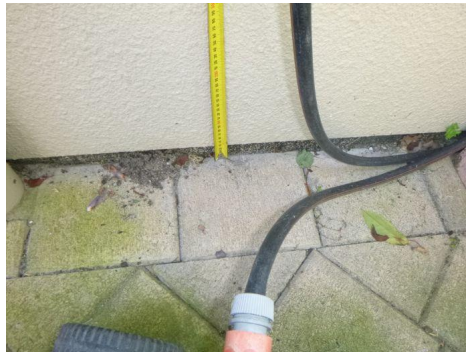
40mm

- X
- Beneath the recommended 100mm clearance between cladding and ground on most places around the home. Although this would not meet today's standard, it does not appear to have lead to any moisture ingress issues.

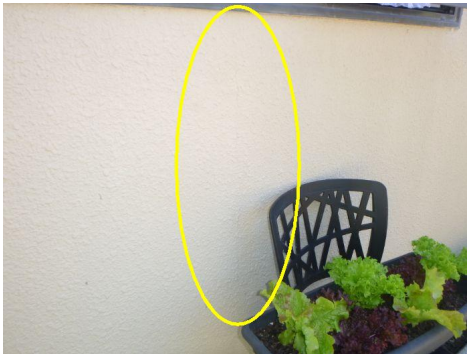
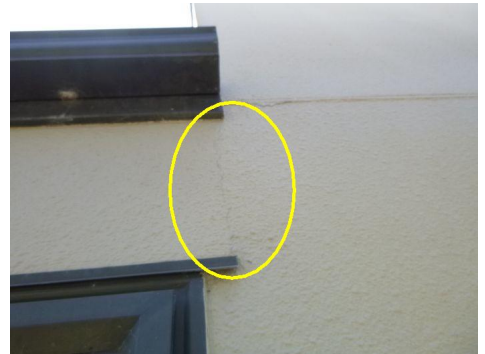
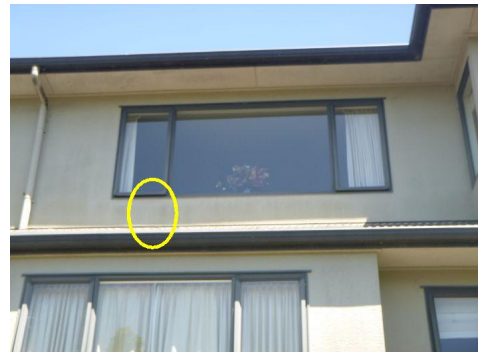
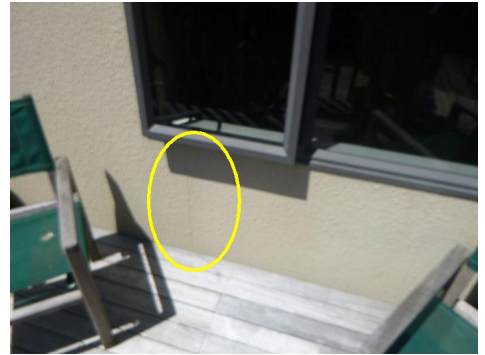
- A lot of cracks present and all appear to be near joinery. All cracks are minor (thin and vertical). This is not uncommon for a building this age. They may only require painting with an elastomeric paint without the need for sealant however I recommend consulting a cladding/painting professional to confirm.

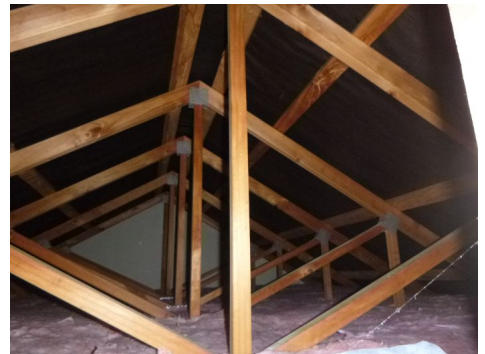
- There is definitely a wall that has been placed in the roof cavity between the two properties. Quite probably fire resistant gib or the like.

Possible fire resistant wall

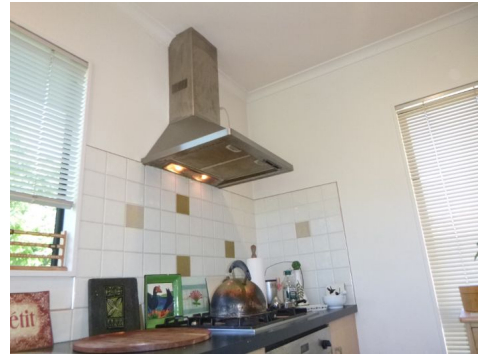
- X
- Although there seems to be the hardware to vent to the exterior of building in 6c, it is bowing back into the kitchen. Perhaps the ducting is blocked or disconnected?
 - Unknown where the discharge point is for 6d - might be just blowing into the kitchen.

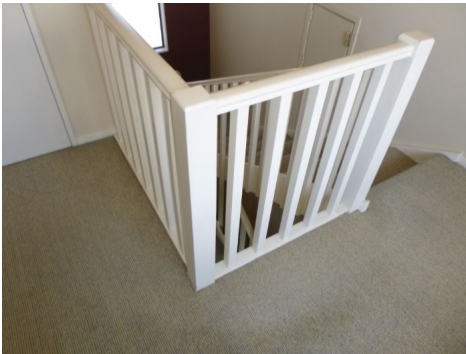
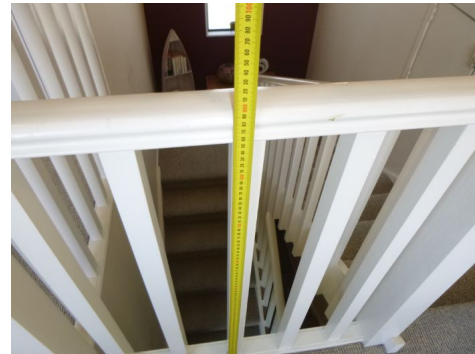
900mm

- X
- Adequately rigid
 - Continuous and extends the full length of the hazard
 - The balustrades at the top of the stairs in both properties are under 1000mm high which is the current standard. Would have been OK at the time of construction.

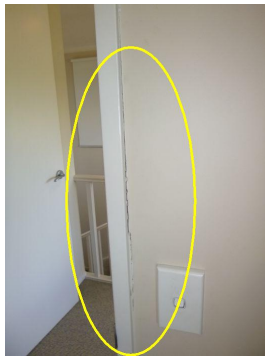
6d upstairs bedroom

M D NI
X • Large cracks between boards in the top bedroom in 6d. Also cracking between door jamb and gib in the same room. Although this appears cosmetic only (no other signs of any movement in the building), it is unsightly.

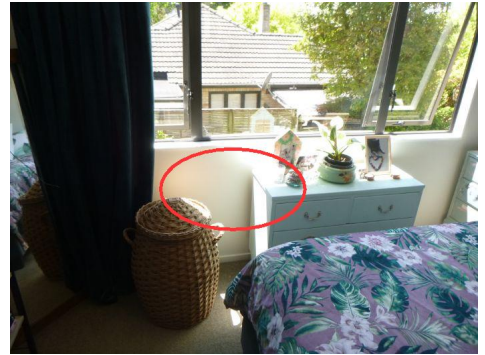
M D NI
X • Several readings were taken and most were within the acceptable range and indicate most of the bedrooms to be DRY.
• Readings taken on a section of wall underneath the window in the downstairs bedroom of 6c were within the higher range and indicate this part of the room to be WET. There is no other indication of moisture ingress - no swelling, no odours, no staining, no warping. The cladding outside the window appears in satisfactory condition. It could be an older issue that has since been resolved?

6c downstairs - Raised readings

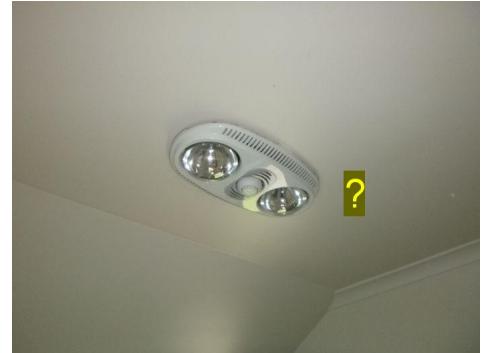
6d upstairs

- X
- Mechanical
 - NOTE: the extractor in the top bathroom in 6d is very quiet and does not appear to be functioning correctly.

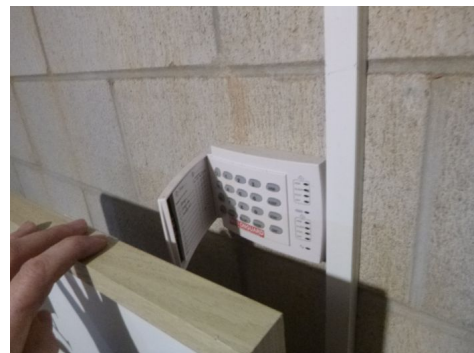
6c

- In garage
- Both do not appear functional
