Inspection Report

Property Address:
23 Holloway Place
Hamilton
Pre Sale / Vendors Report .

23 Holloway Place, Hamilton

Total House Inspections

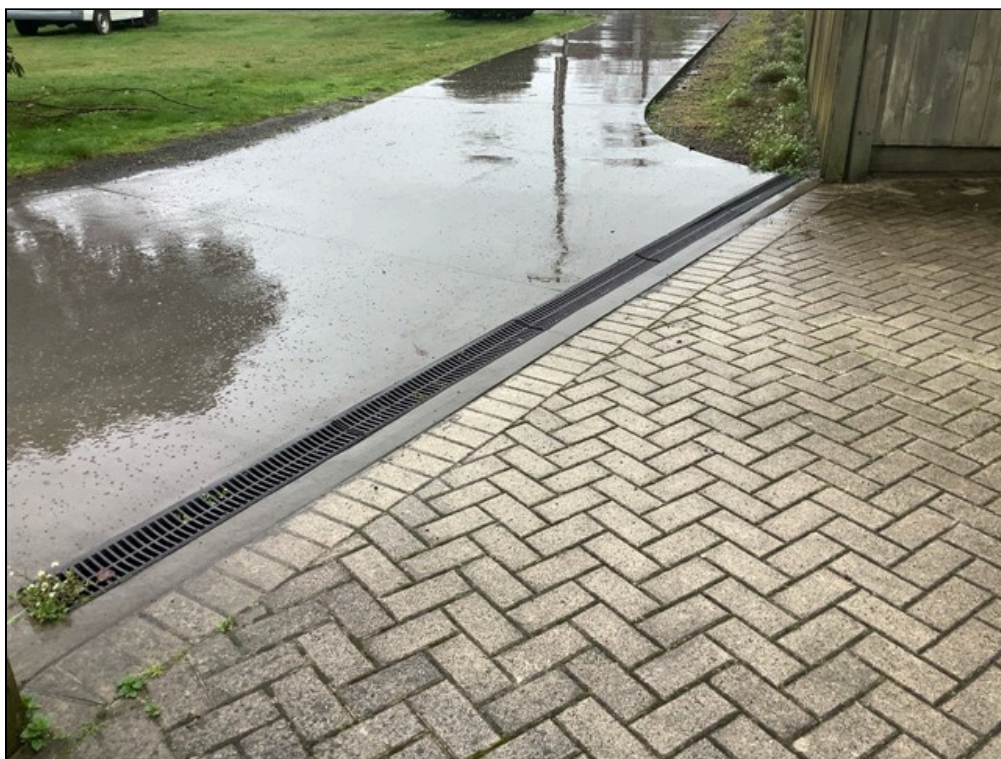
1.8 There is a channel grate drainage system installed on the south eastern side of the driveway. **This ground surface drain may need periodical cleaning and maintenance to ensure that it works as efficiently as possible and prevent it blocking.**

1.8 Item 1(Picture) Channel Grate Drain On The South Eastern Corner Of The Cobble Driveway

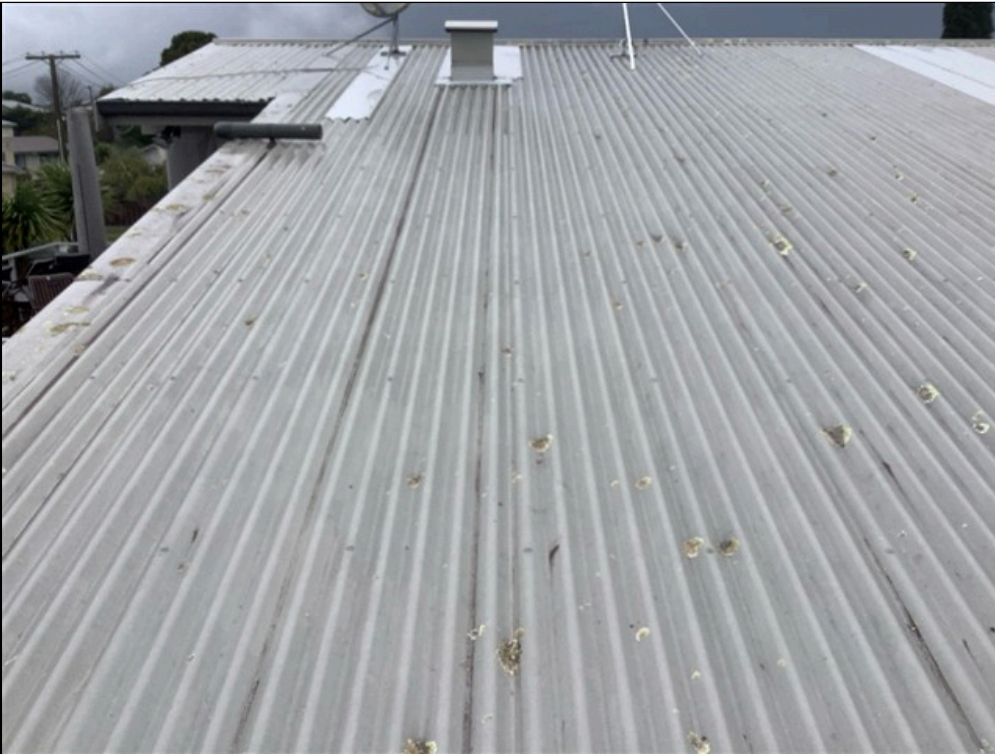
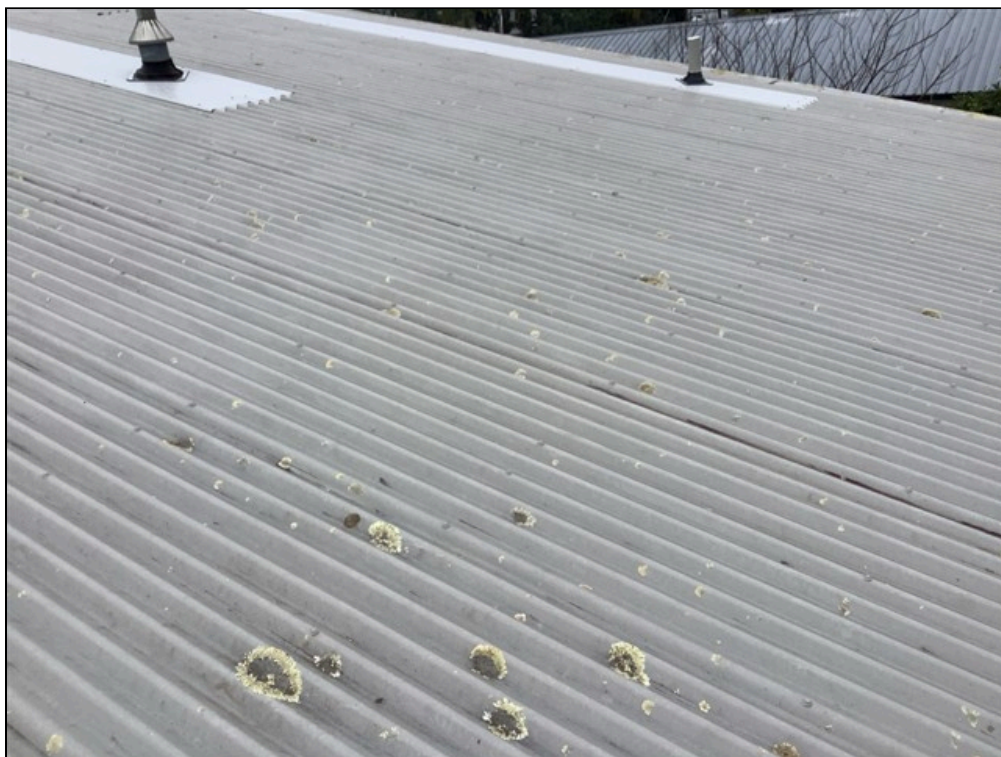
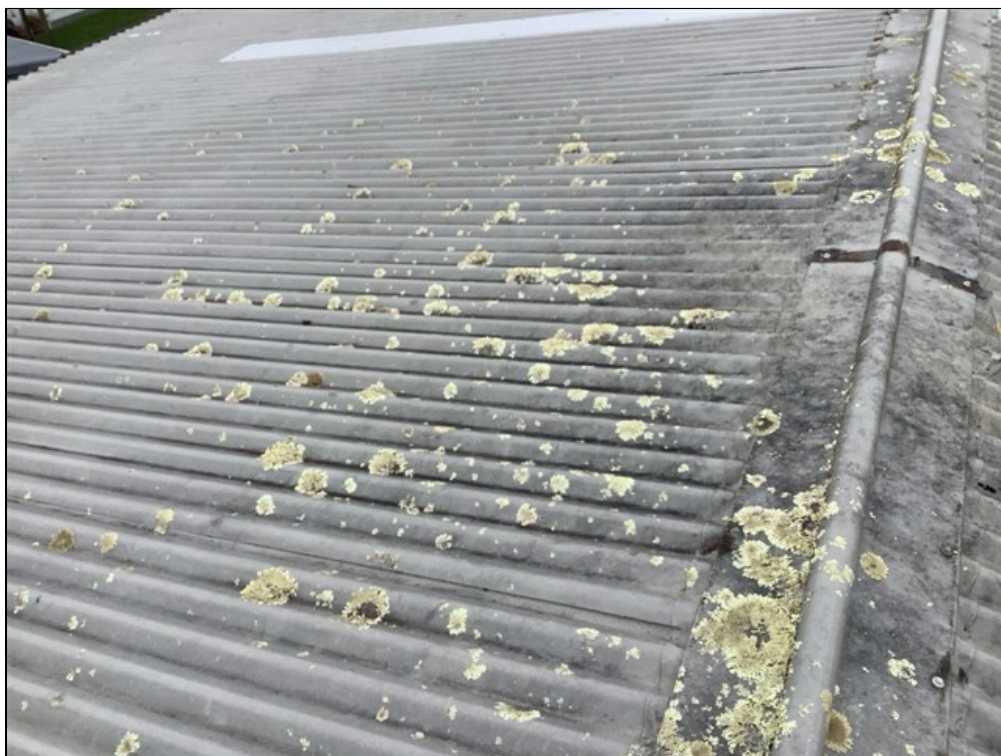
2.2 There are spools of Lichen that are present in areas on the roof. It is believed that the current house owner got the roof treated for this Lichen around the 27th of May 2025 by Pro Waterblasting Hamilton. Once treated the Lichen spools will die and fall off in time, but in some cases it does need a gentle hand with a soft brush off. If still present in 6-9 months then it may need another treatment. *Please note that the photos attached to this section of the report are examples only and may not represent all areas.*

2.2 Item 1(Picture) Lichen Present On The Roof Has Been Treated

2.2 Item 2(Picture) Lichen Present On The Roof Has Been Treated

2.2 Item 3(Picture) Lichen Present On The Roof Has Been Treated

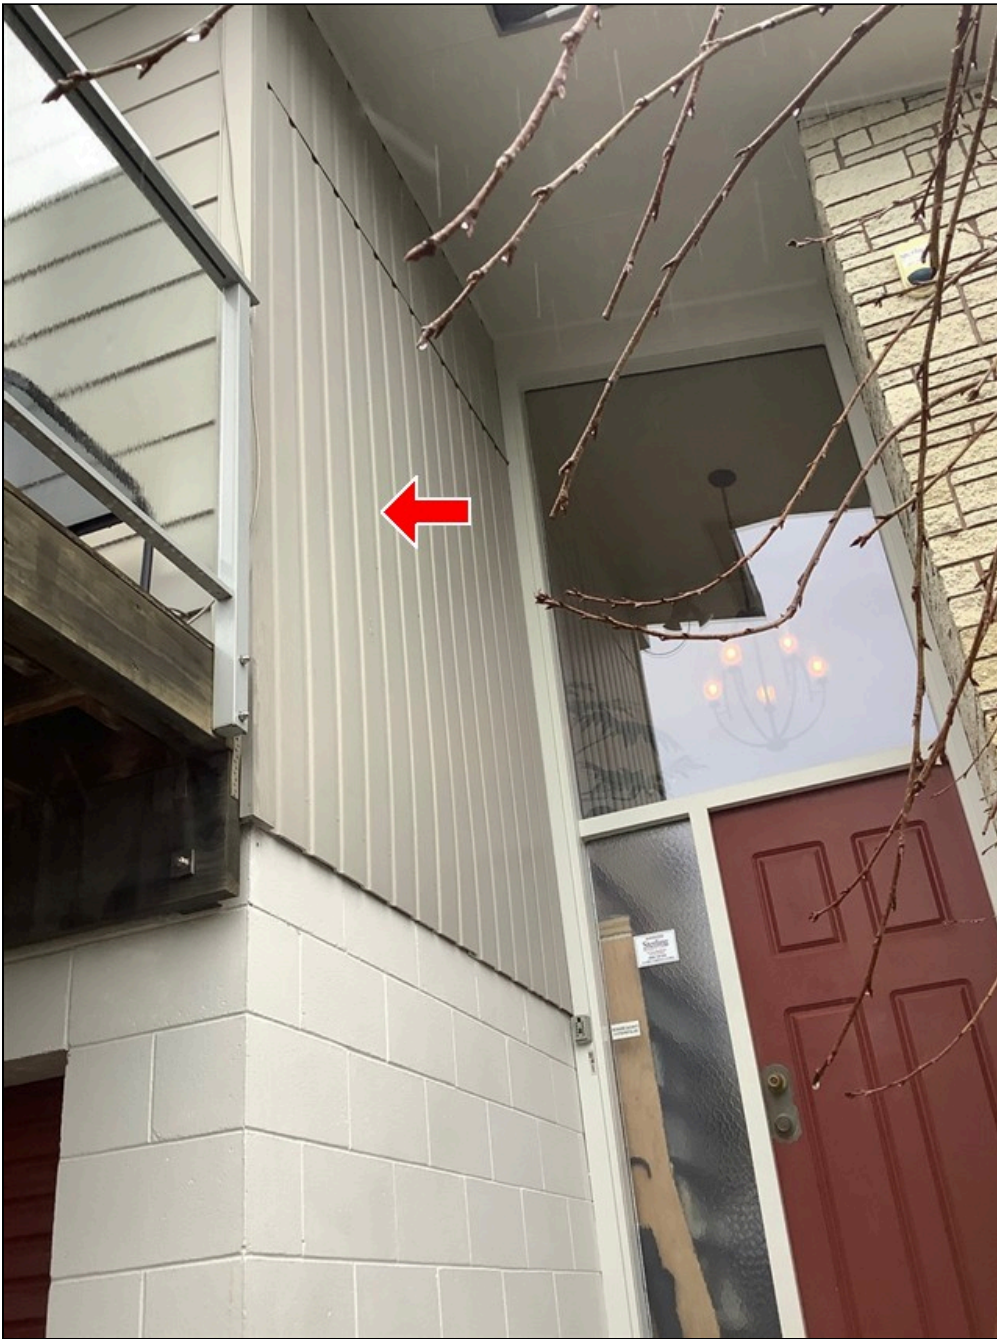
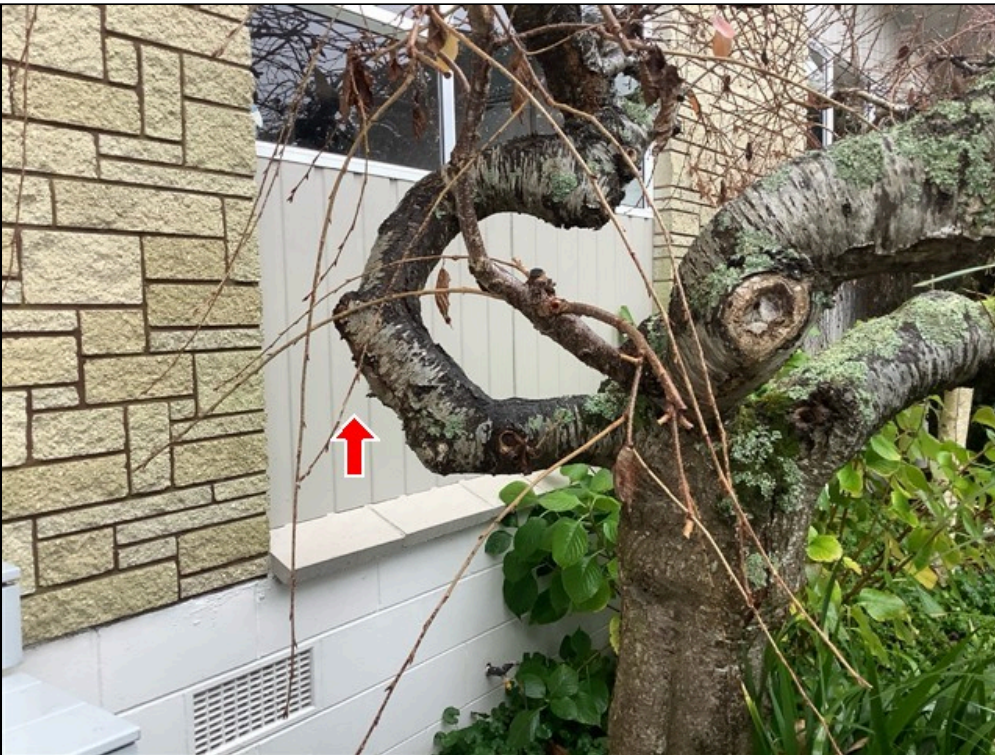
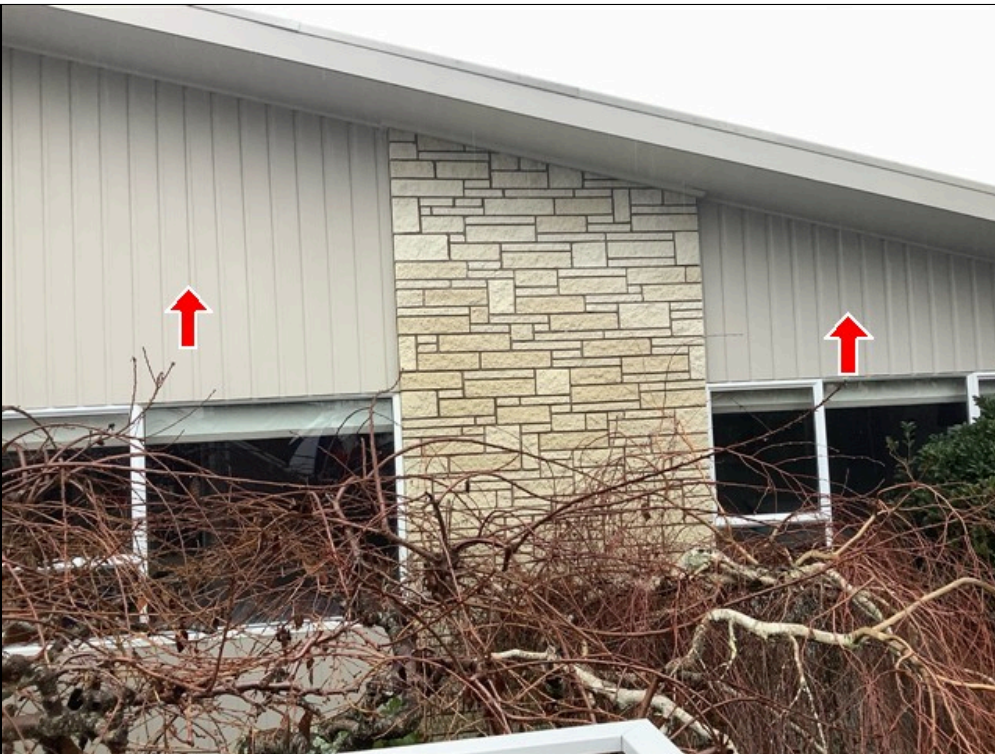
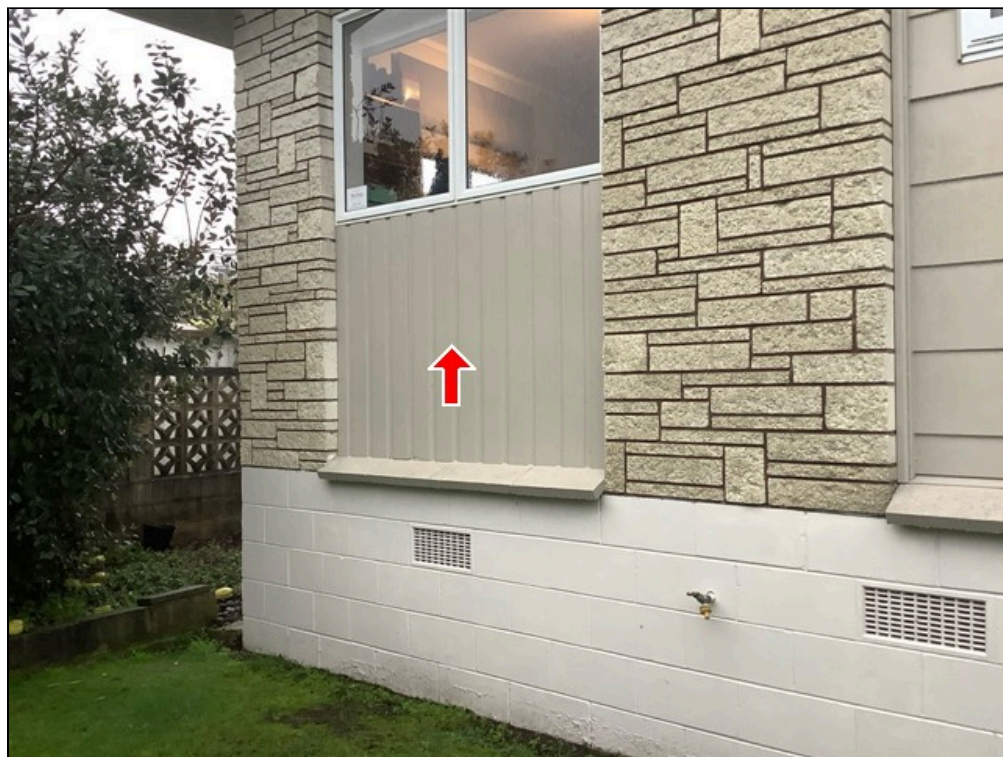
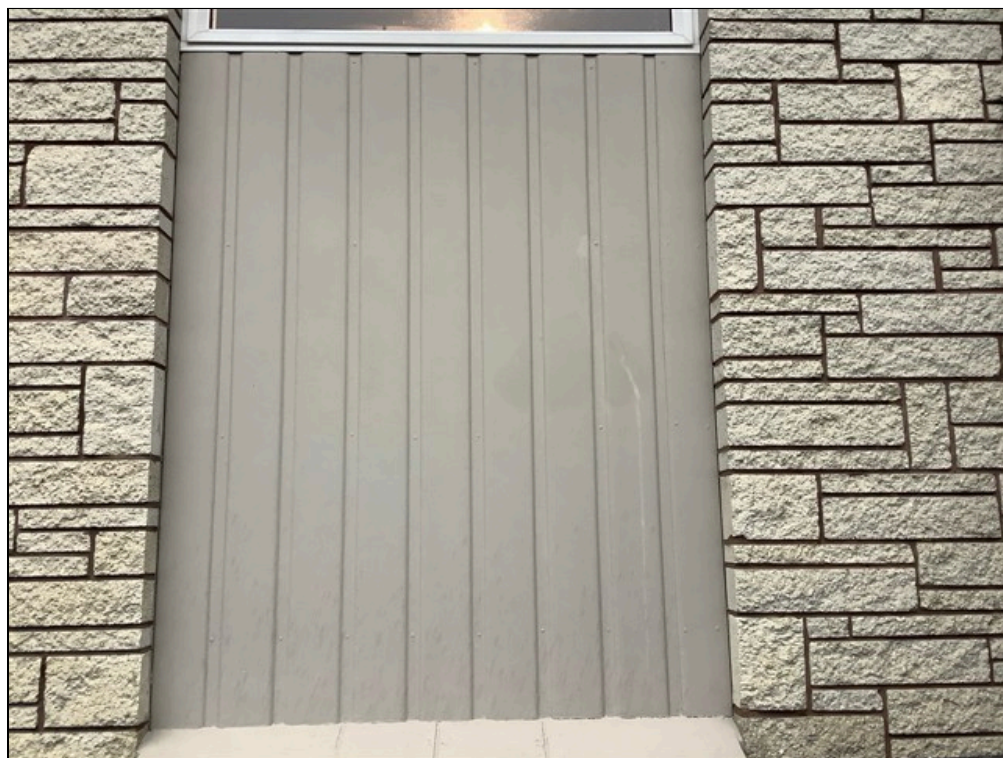
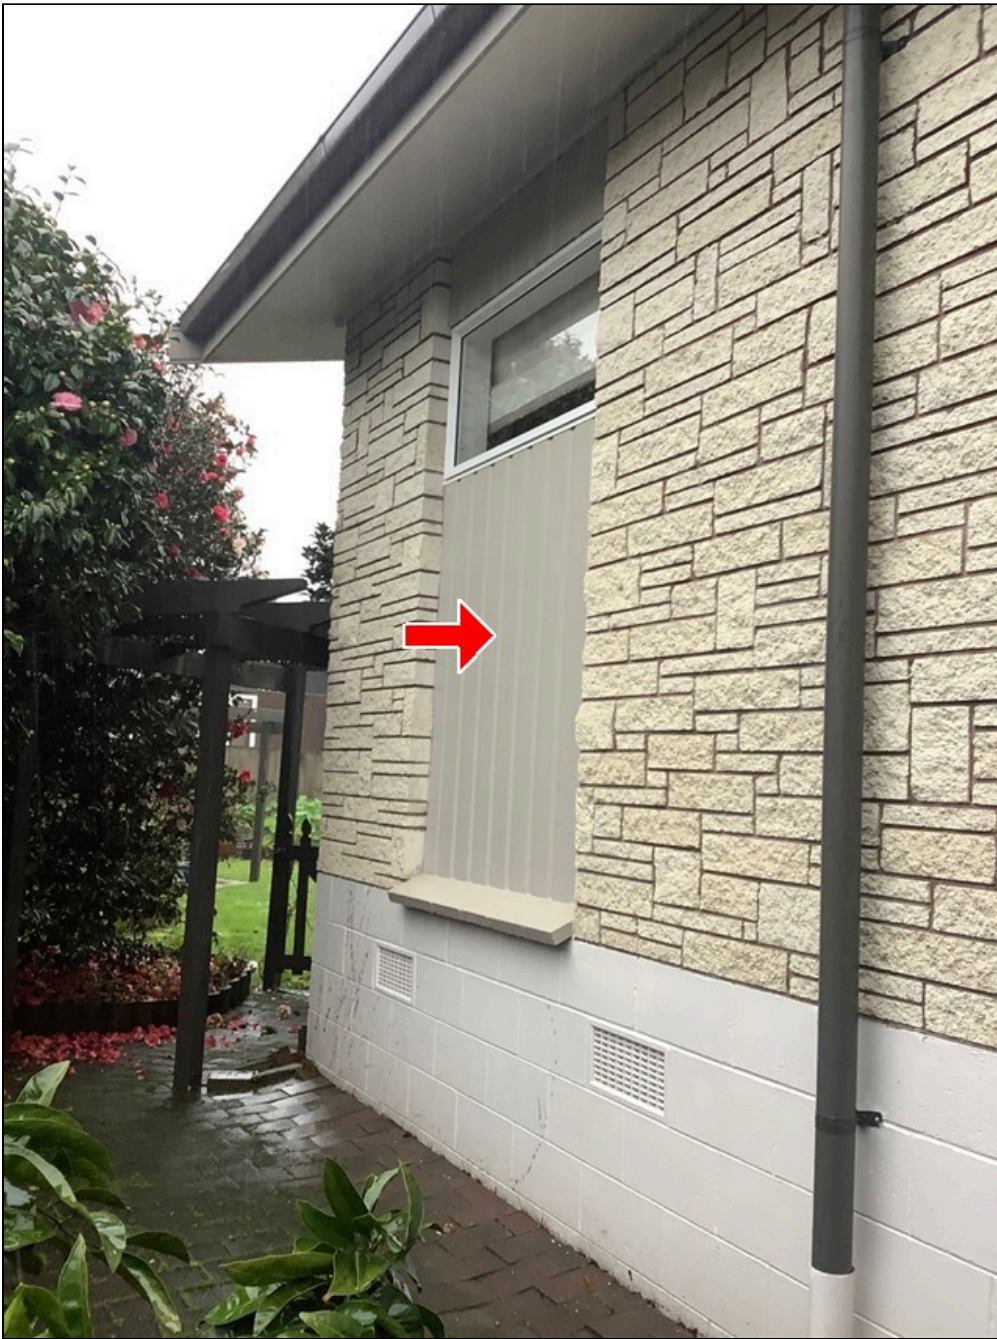
The cladding sheet material that is present around the Front Entrance and underneath and above the windows around the house is constructed from Asbestos materials. If kept in clean and good condition, asbestos poses no threat and is only a concern when removing or carrying out maintenance on the material. If left in situ and in good condition, this cladding is very robust and strong and will last longer than most other materials on the house. If intending to carry out any maintenance or removal of this sheeting, we strongly recommend to seek the professional advice from an Asbestos specialist to test and confirm that this product is asbestos and how best to deal with it.

3.2 Item 1(Picture) Asbestos Sheets In Some Areas Around The House

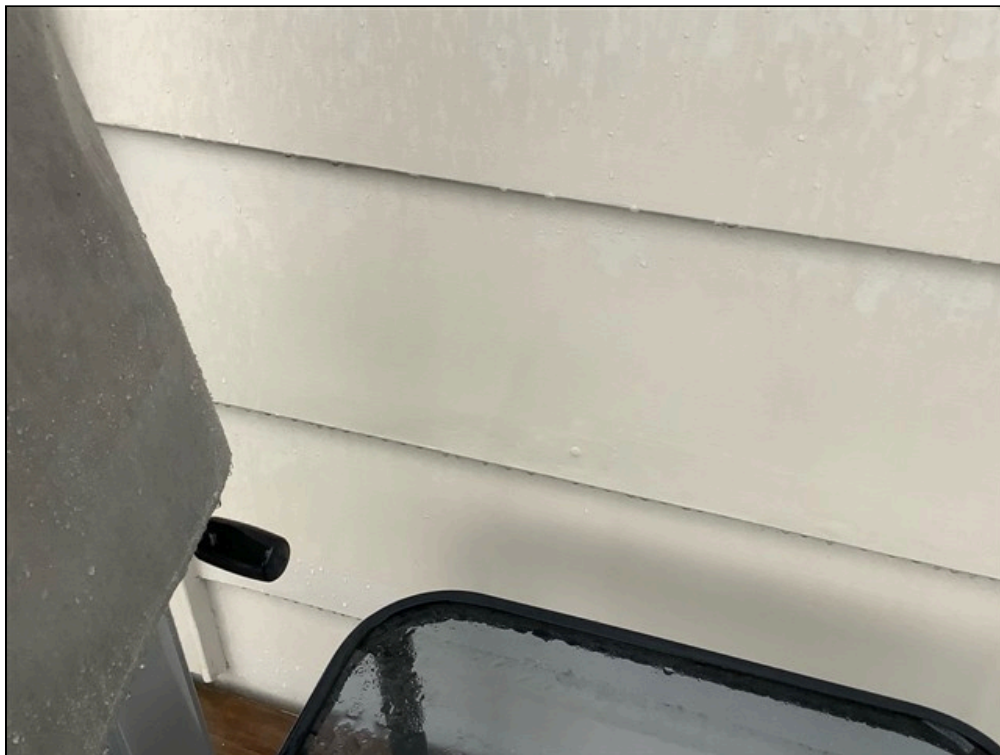
Condition Of Cladding: Some of the original weatherside planks have been replaced with the alternative Fibre Cement material. It is difficult to tell the difference once it is all painted but there are areas on the eastern side of the timber deck and western side of the house that have been replaced. The exterior cladding is painted well and is sealed. There were some mild signs of swelling to some areas of the original planks but these areas are not needing attention at this time. While we cant guarantee that further planks may need replacing in the future, in general the cladding appeared to be in acceptable condition. We recommend that good maintenance is continued and repairs completed if needed.

3.2 Item 7(Picture) Some Cladding Planks Are Weatherside Material & Some Have Been Replaced With Fibre Cement

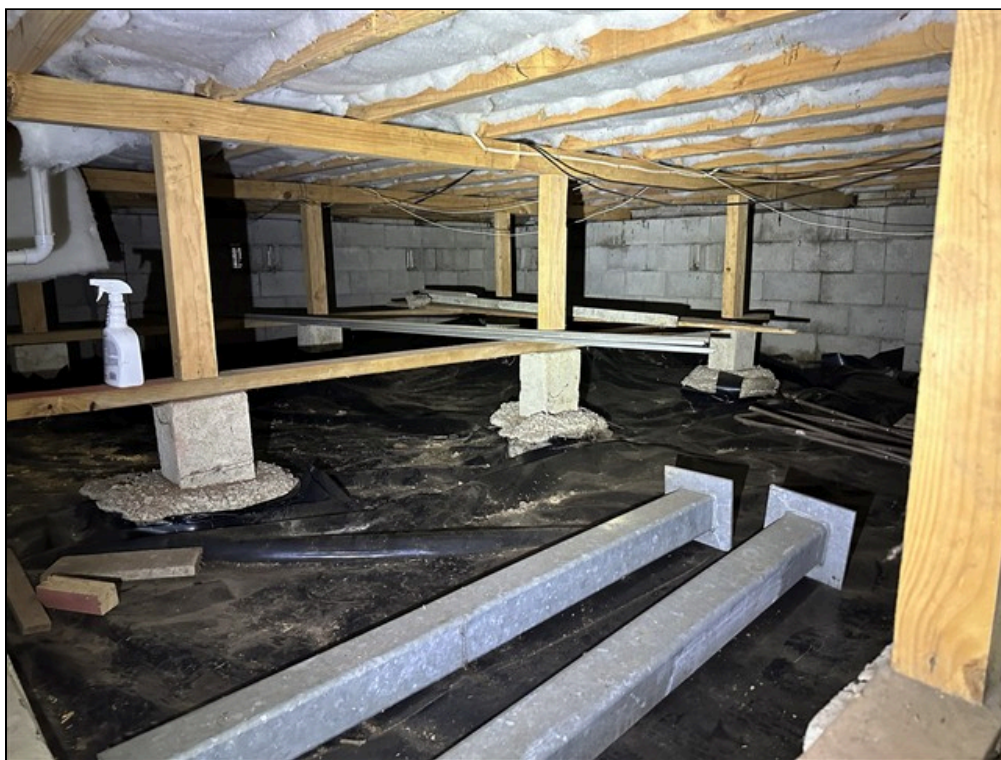
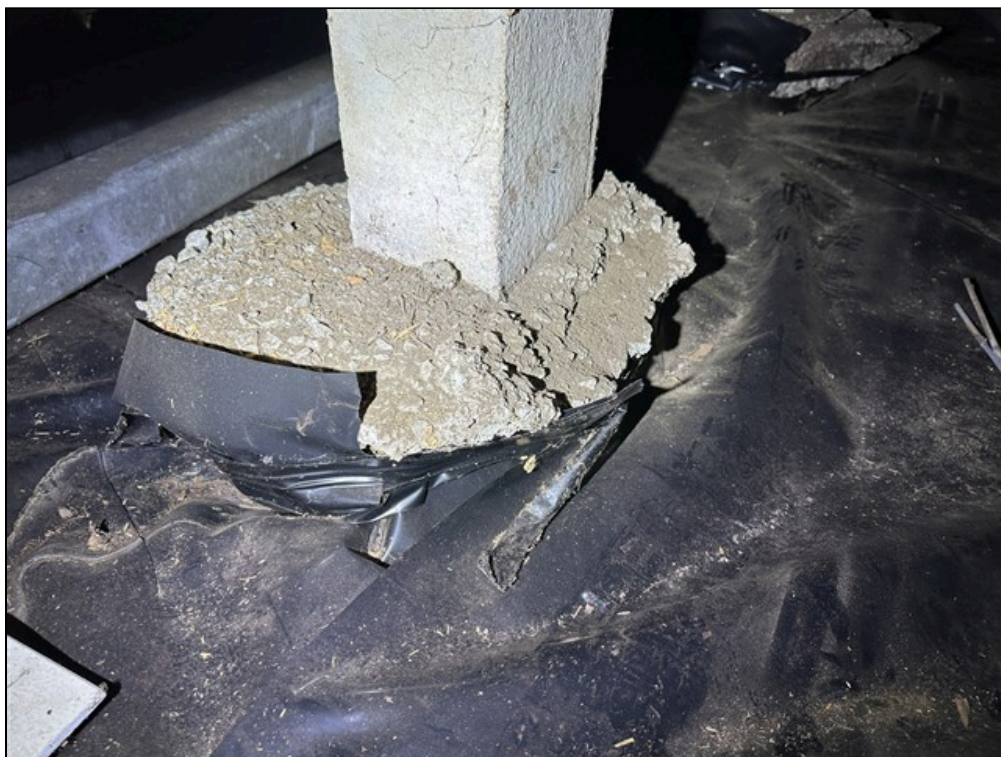
Information: It was previously noted that some subsidence to the soil has occurred around certain piles, exposing some of the concrete. On the 7th of July 2025, the foundations were assessed by Soil Eng Foundation Engineering. They have completed a full report on the foundations and piles. We make reference to page 10 on that report which states the following;

"To put the above in perspective the soil that supports the bottom of the piles and house can provide three times more resistance than what is actually required. This is further confirmed by our visual inspection of the house exterior and not finding any indications that the house is currently under foundation stress."

From our perspective, there were no signs of any movement noted around the exterior of the house or from the inside when inspecting these areas. This is more for your information and understanding why the soil has dropped from around certain piles.

4.3 Item 1(Picture) Some Soil Has Dropped From Around Certain Piles

4.3 Item 2(Picture) Some Soil Has Dropped From Around Certain Piles

We recommend that you obtain a copy of this report to carry out your own due diligence on what was completed and all their findings.

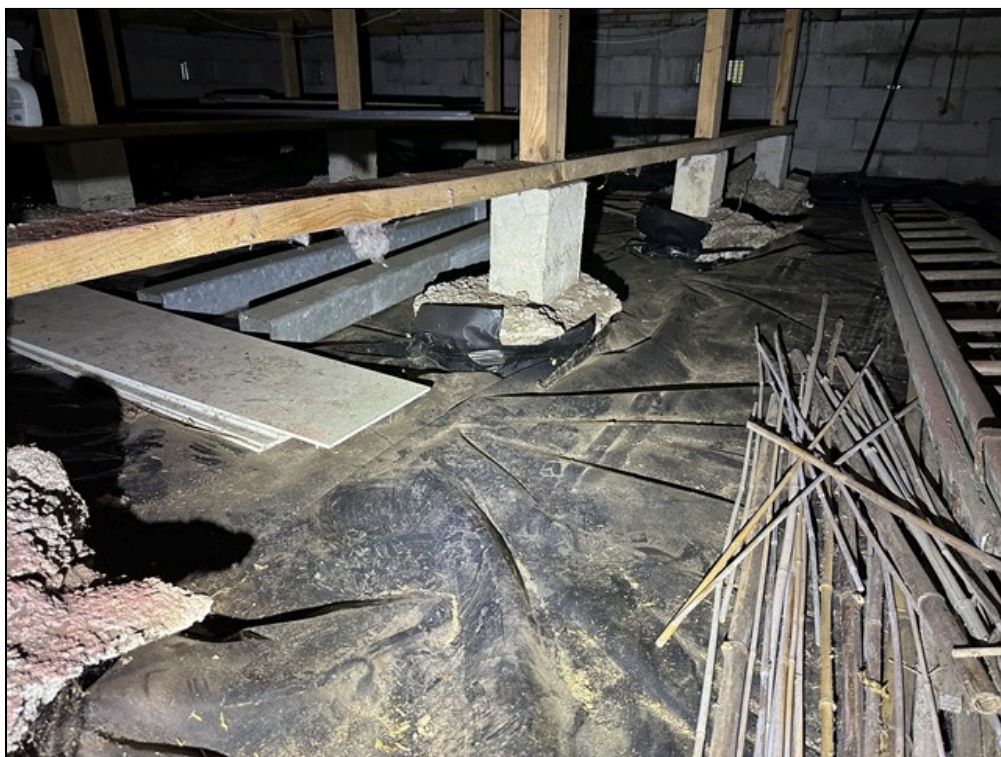
4.6 There is a ground vapour barrier used in the subfloor framing area under the house. This is a good feature as it prevents moisture from rising out of the ground and making the under floor damp.

4.6 Item 1(Picture) Ground Vapour Barrier Installed

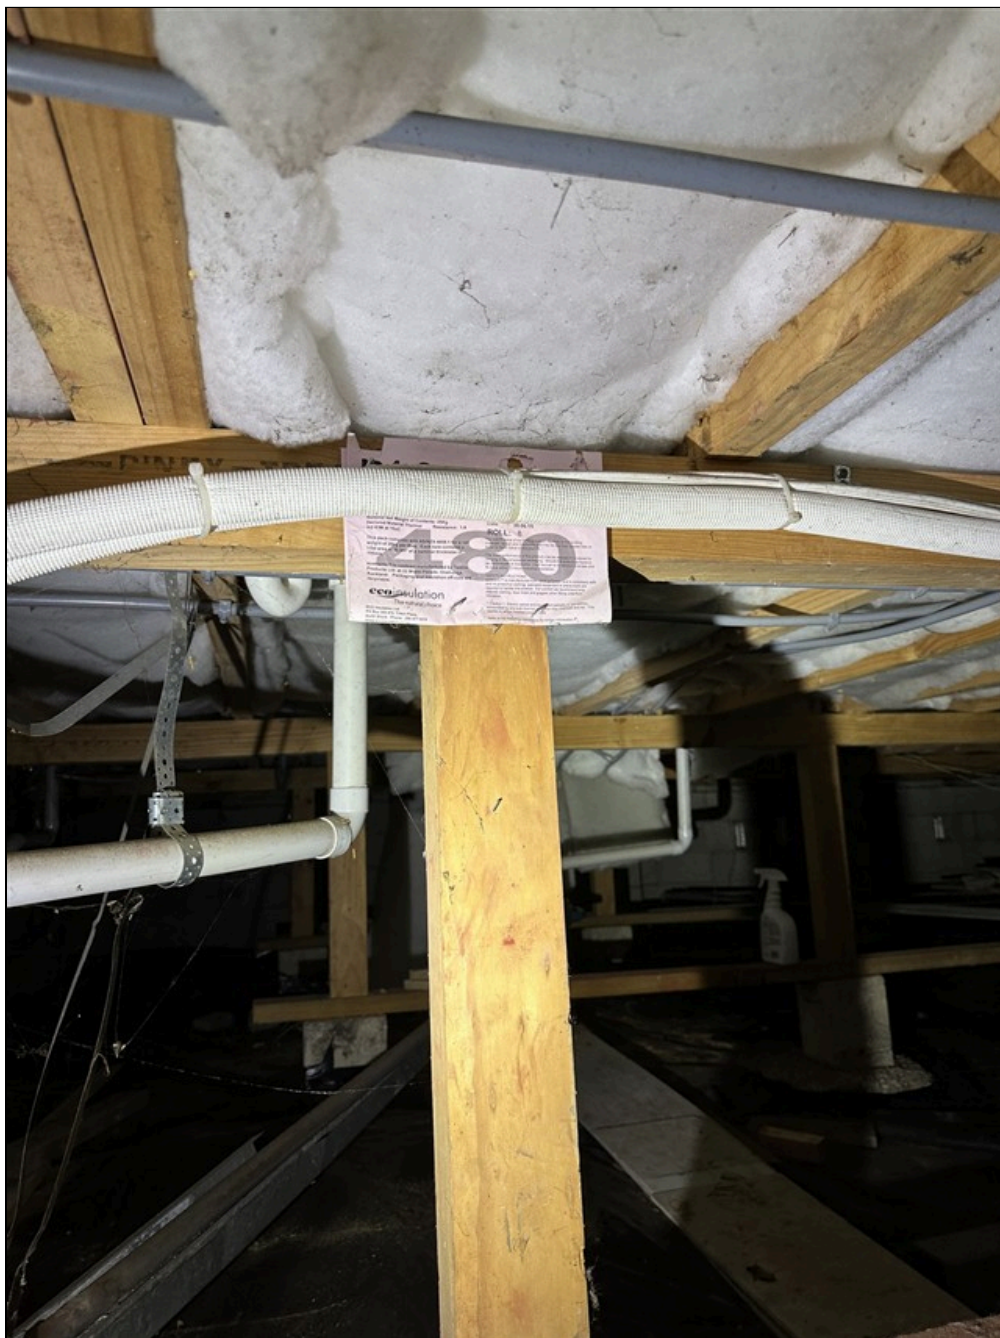
4.14 There is coverage of Polyester insulation installed in the Subfloor Area of the house. This insulation is approximately 50mm thick and it is approximately covering 95% of the total area of the Subfloor Area.

4.14 Item 1(Picture) Polyester Insulation Installed In The Subfloor Area Of The House

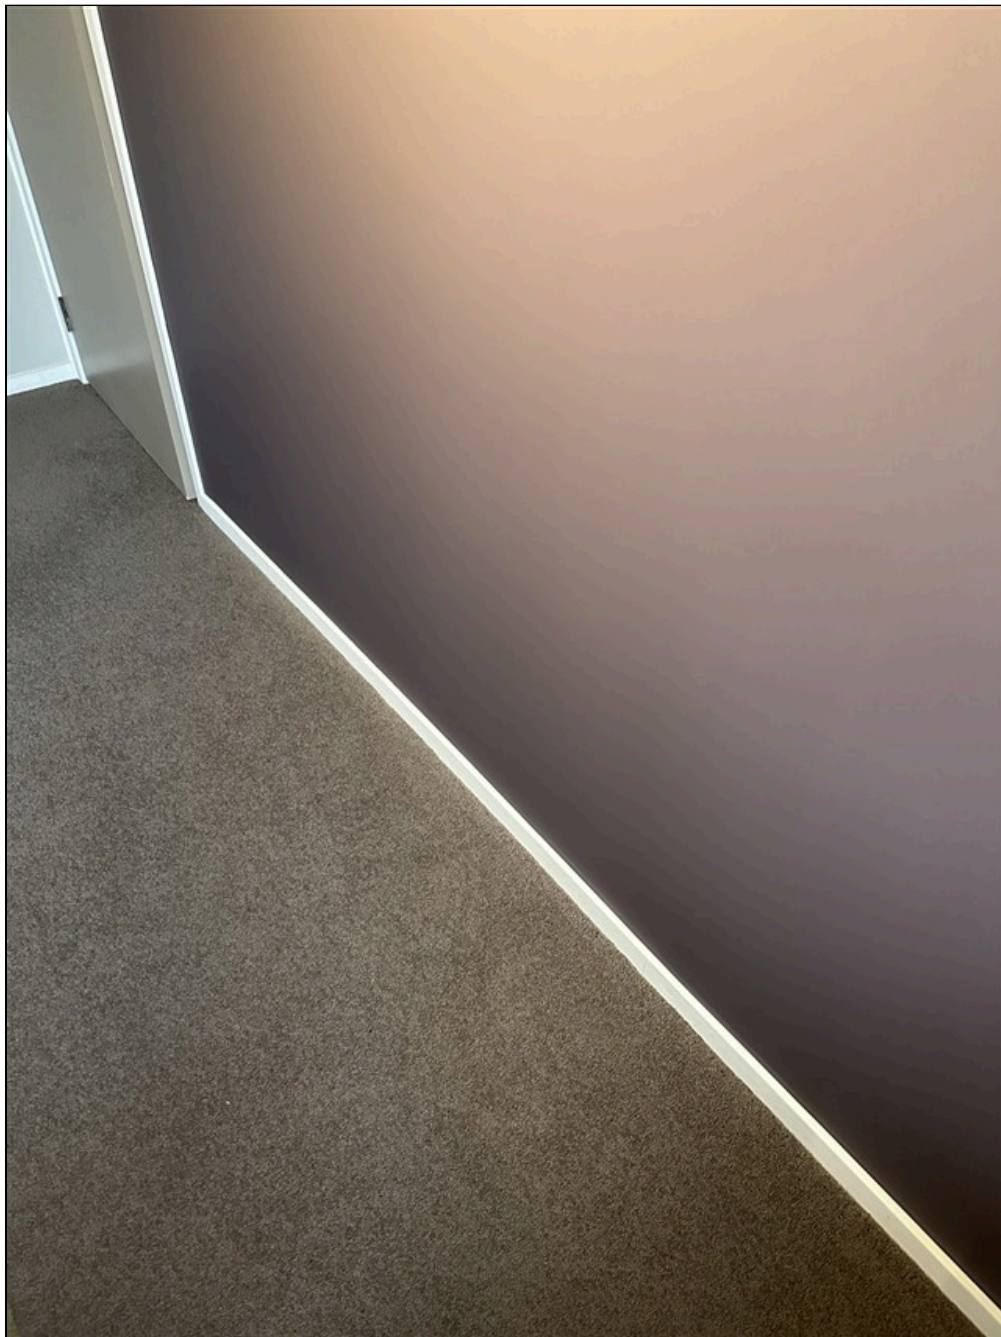
5.19.F Item 1(Picture) Wall Behind The Shower Unit Where Initial Leak Was

While the wall was open, dryers were used to air out the damp timber and fans were also used underneath the house to dry out any moisture in the flooring. The faceplate on the mixer was sealed and the wall was eventually lined and plastered again. During our inspection we completed a good moisture test on this wall and there were no indications of any elevated readings identified. Please find attached to this section of the report, a letter from the Building Contractor who completed the further investigations and repairs to the wall. Some finishing off is still required to the underside of the floor and the Builder has agreed to complete the final reinstatement of the timber.

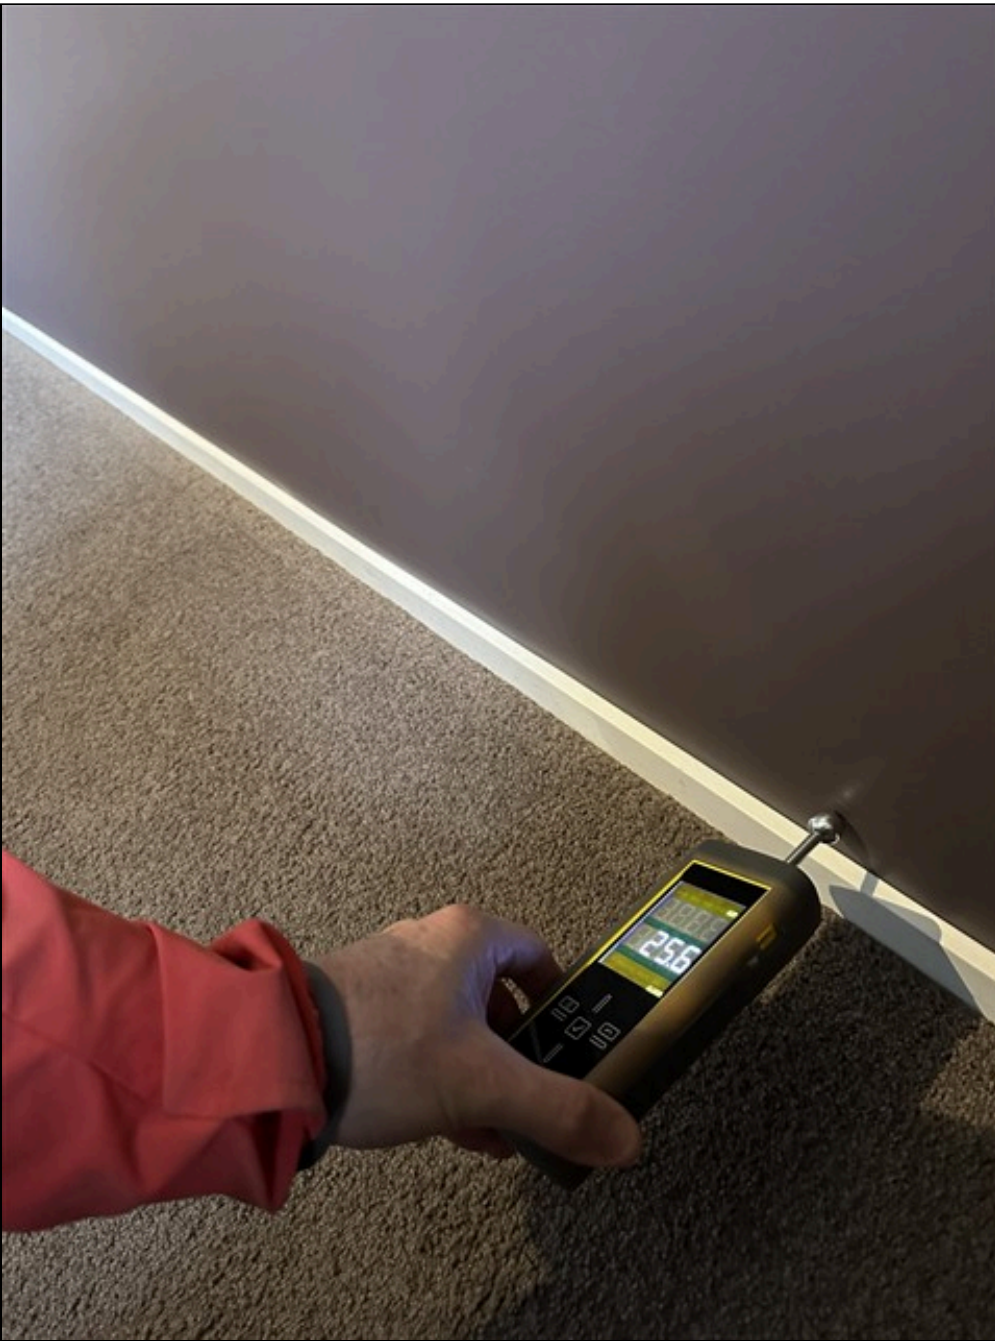
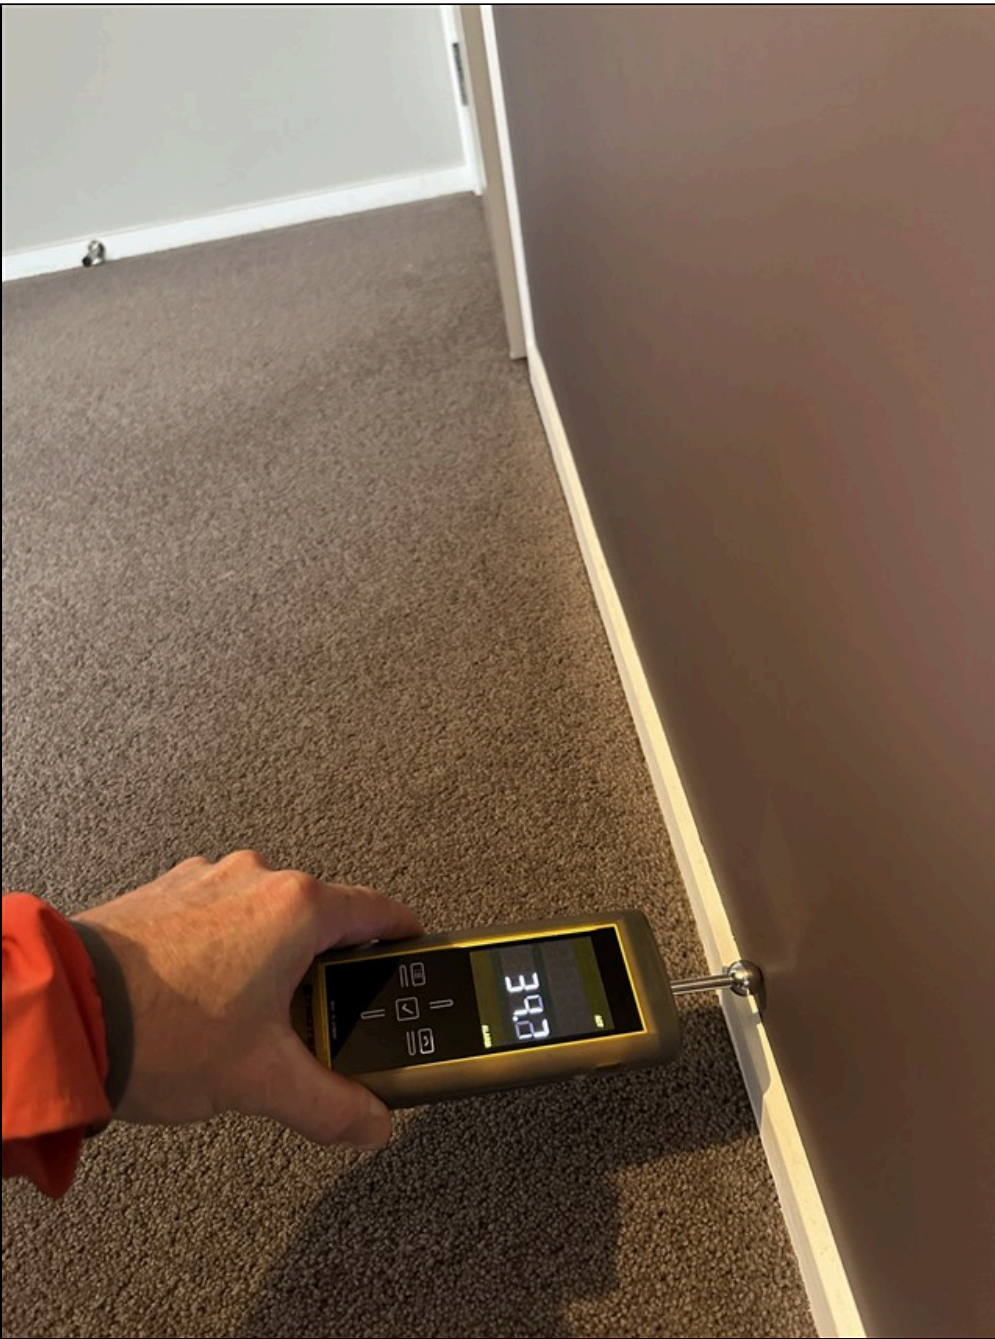
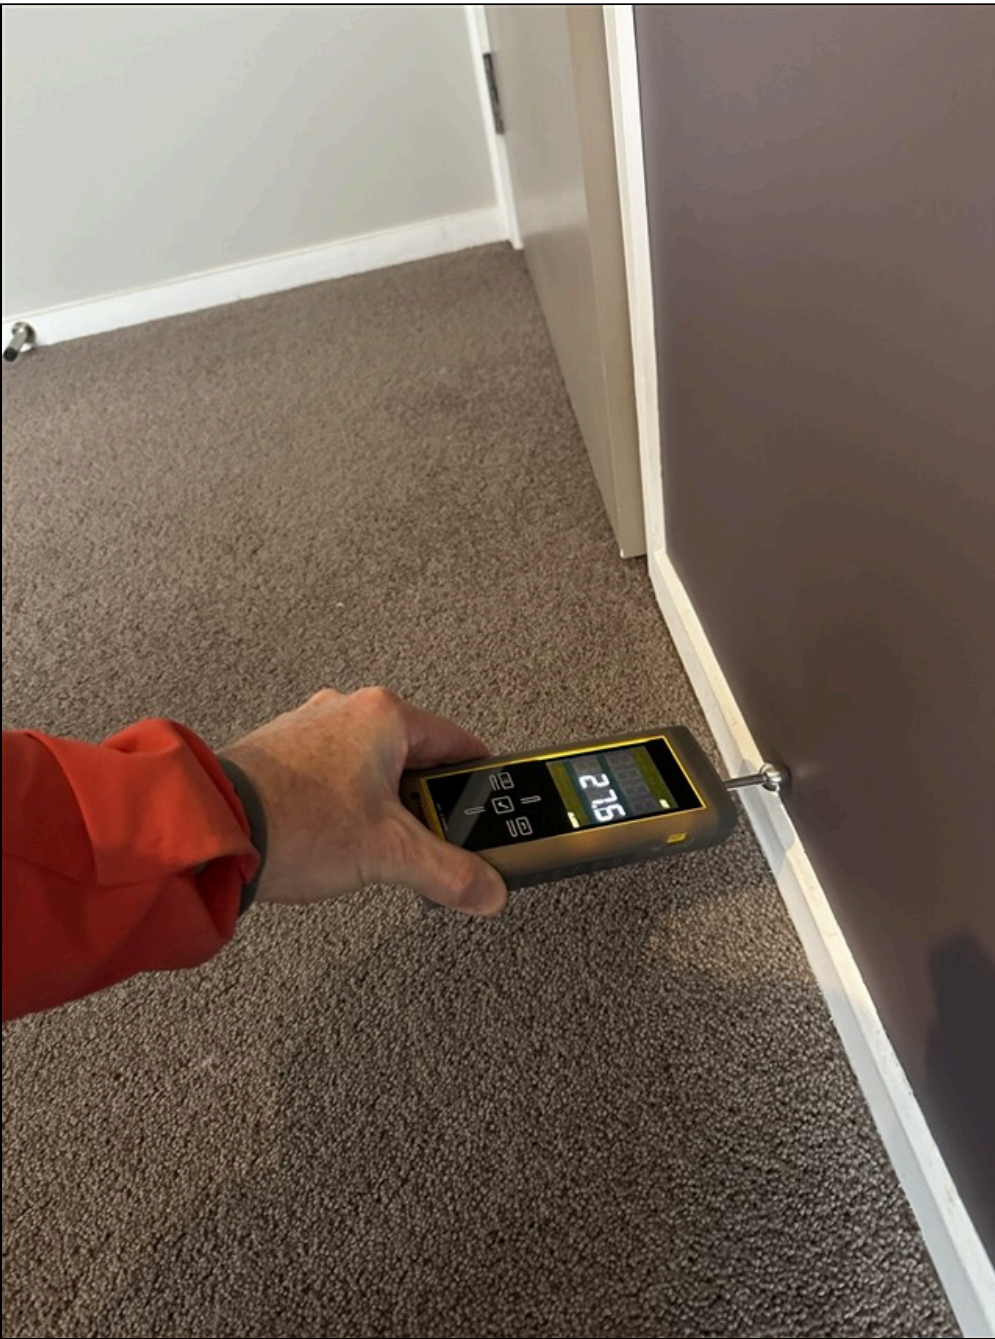
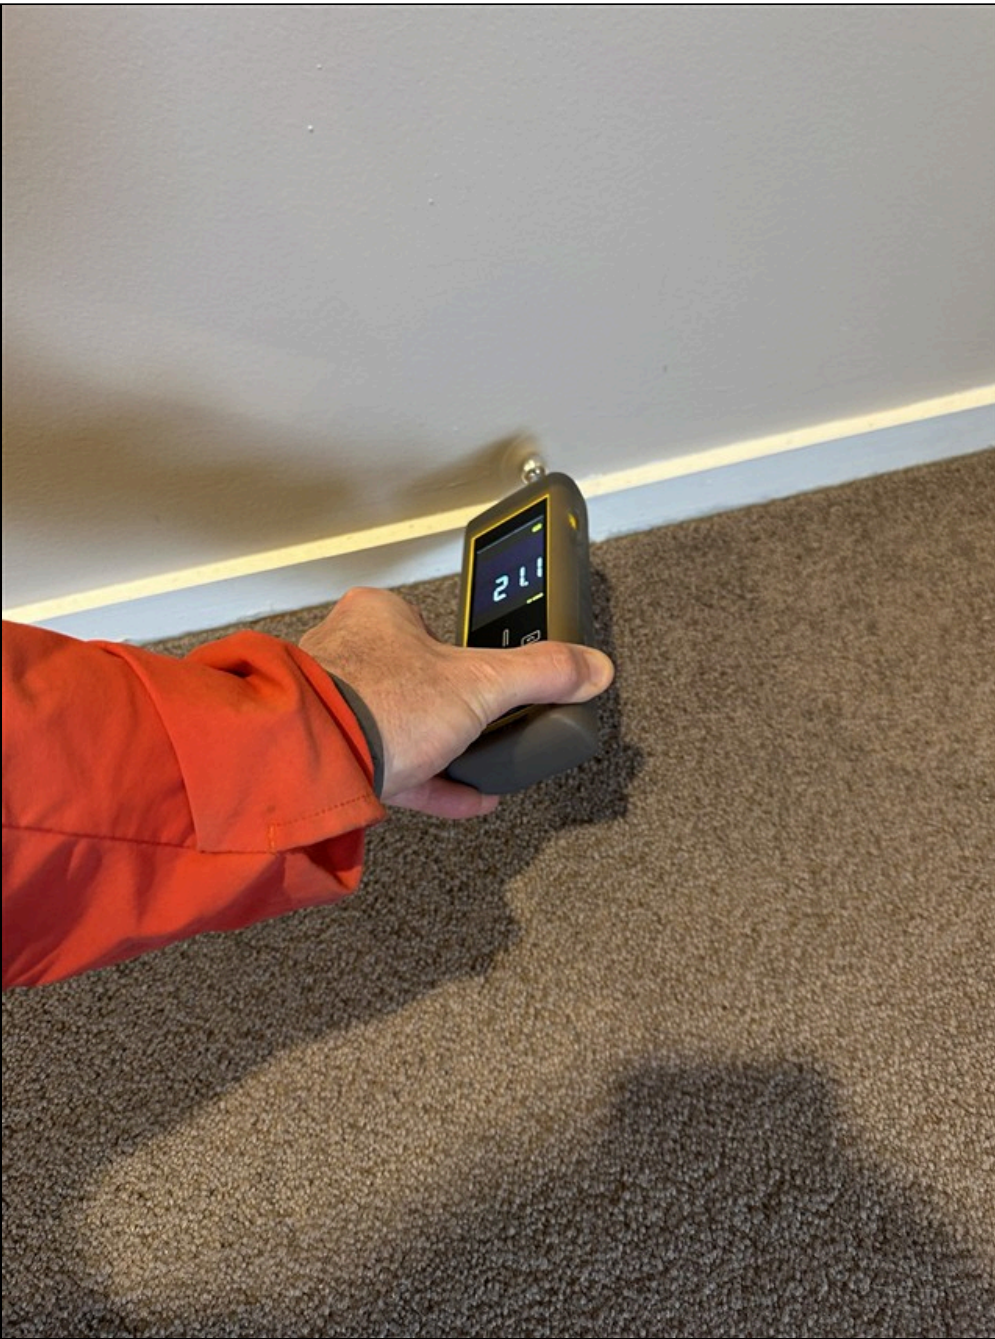
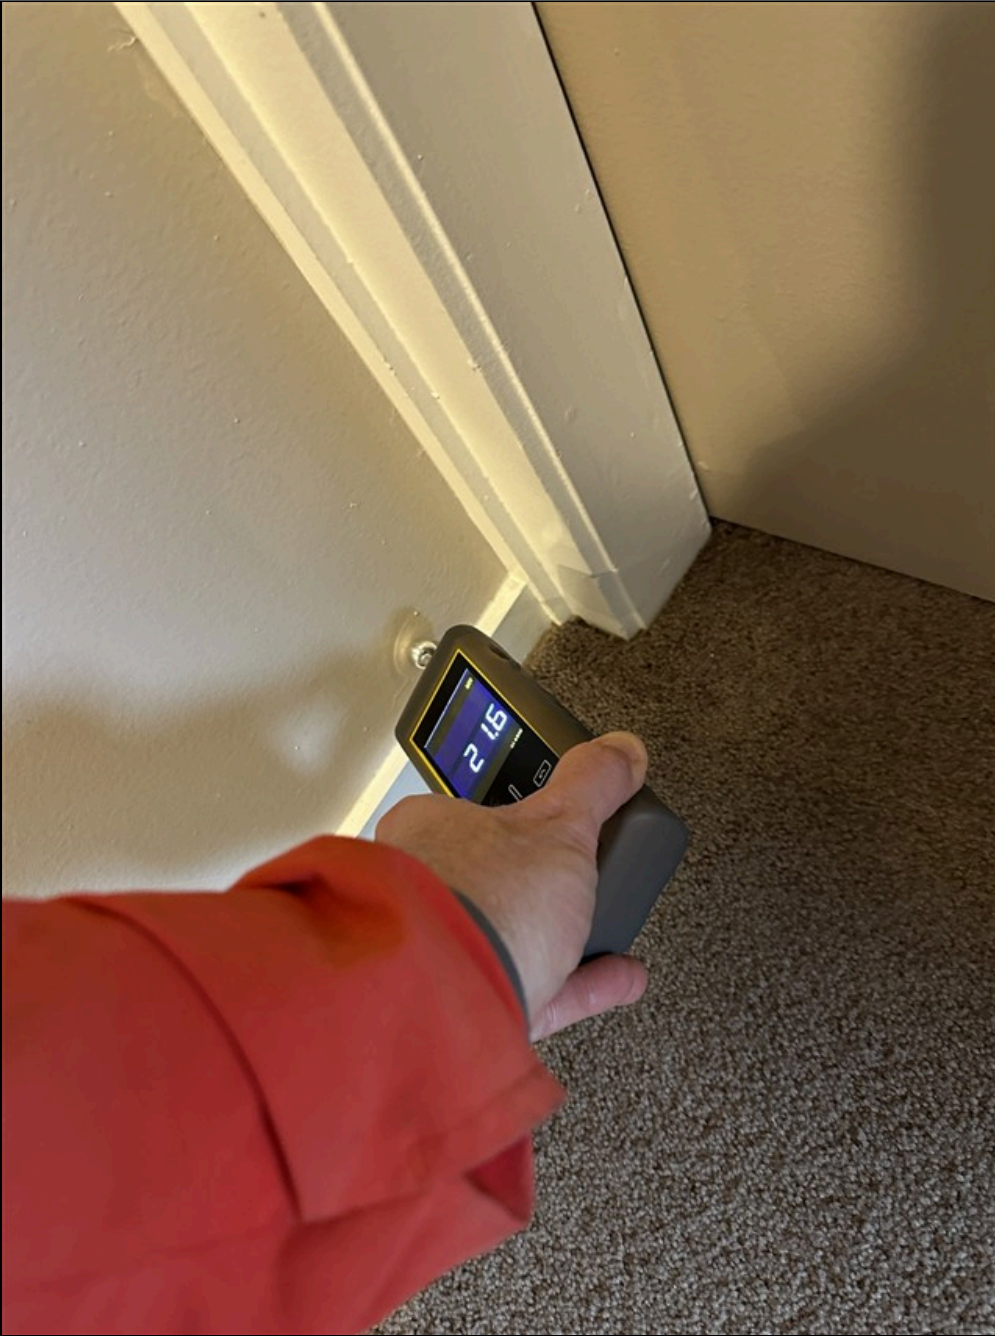
5.19.F Item 2(Picture) All Moisture Levels Within The Dry Range When Tested
