Inspection Report

Property Address:
23 Holloway Place
Hamilton
Pre Sale / Vendors Report .

23 Holloway Place, Hamilton

Total House Inspections

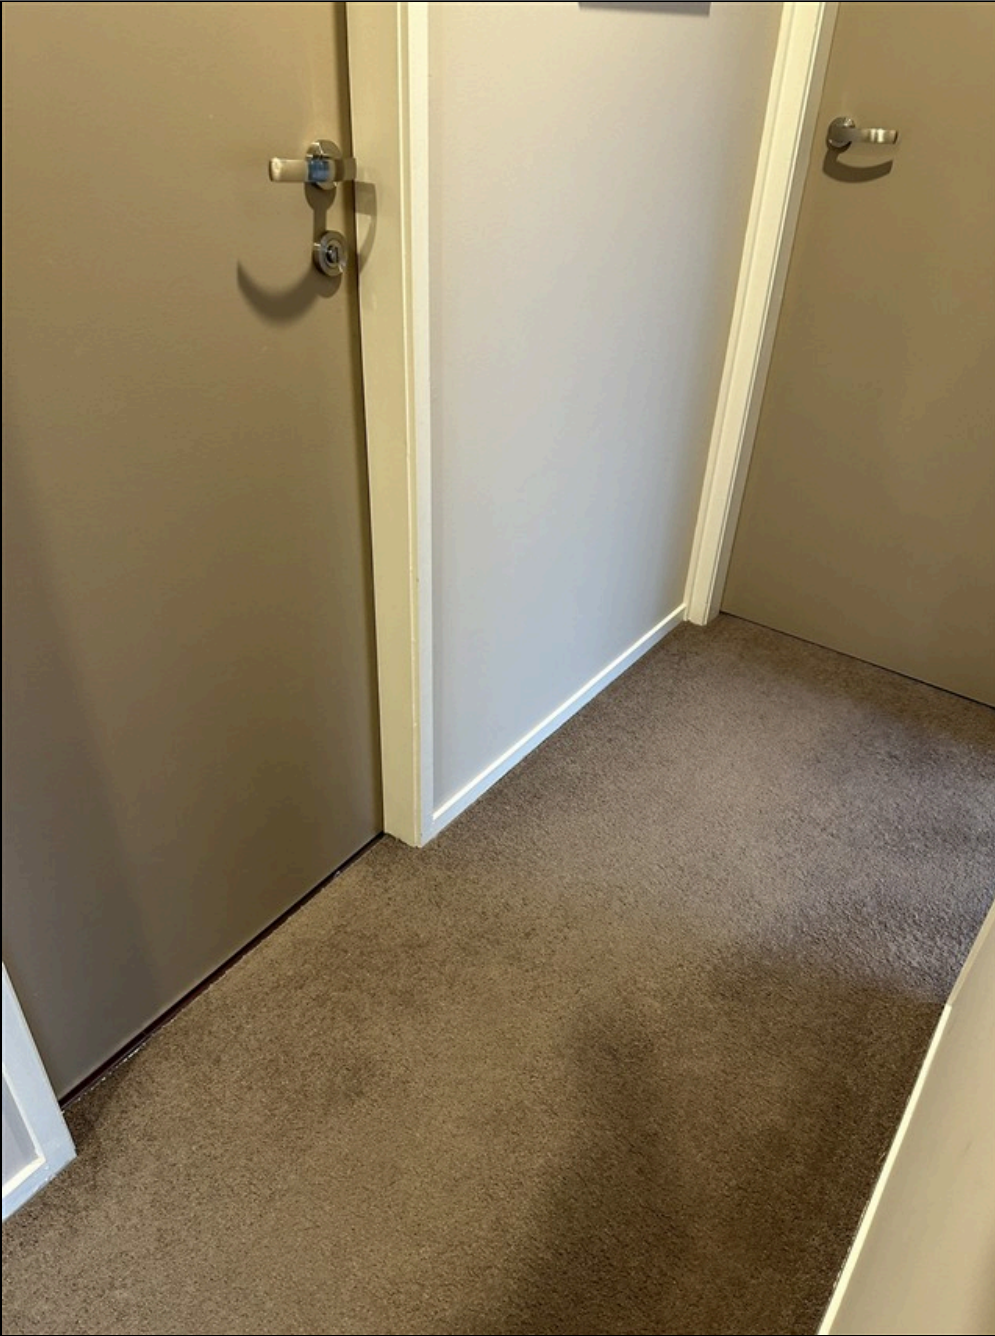
5.19.F Item 5(Picture) Hallway Wall Behind The Shower

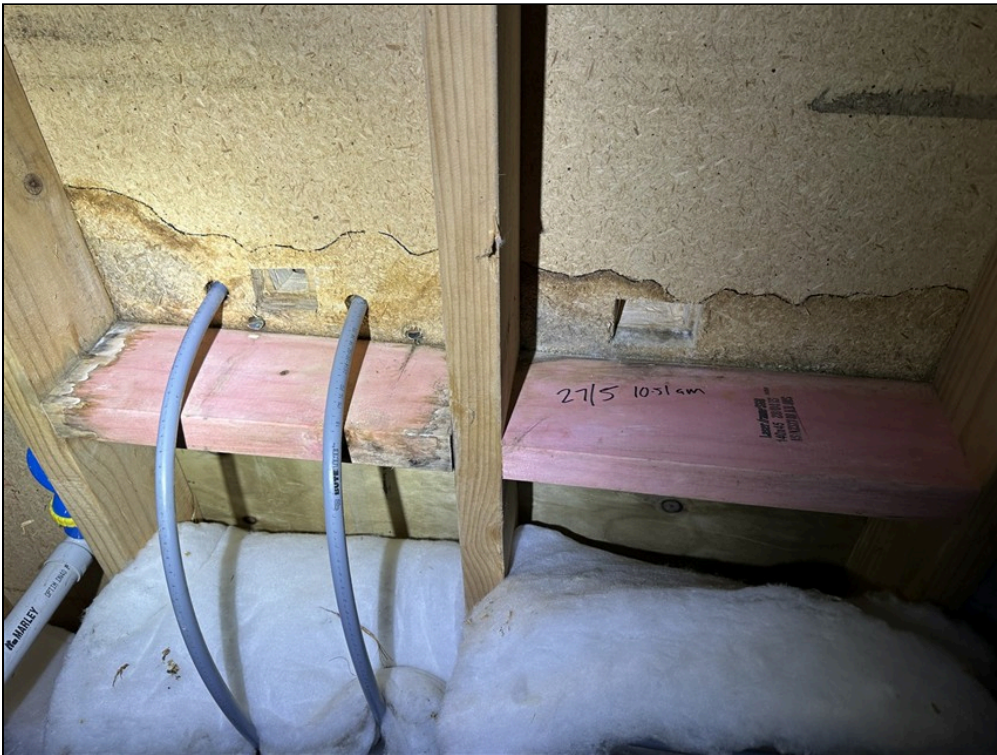
5.19.F Item 8(Picture) Extent Of The Water Leak Underneath The House In The Subfloor

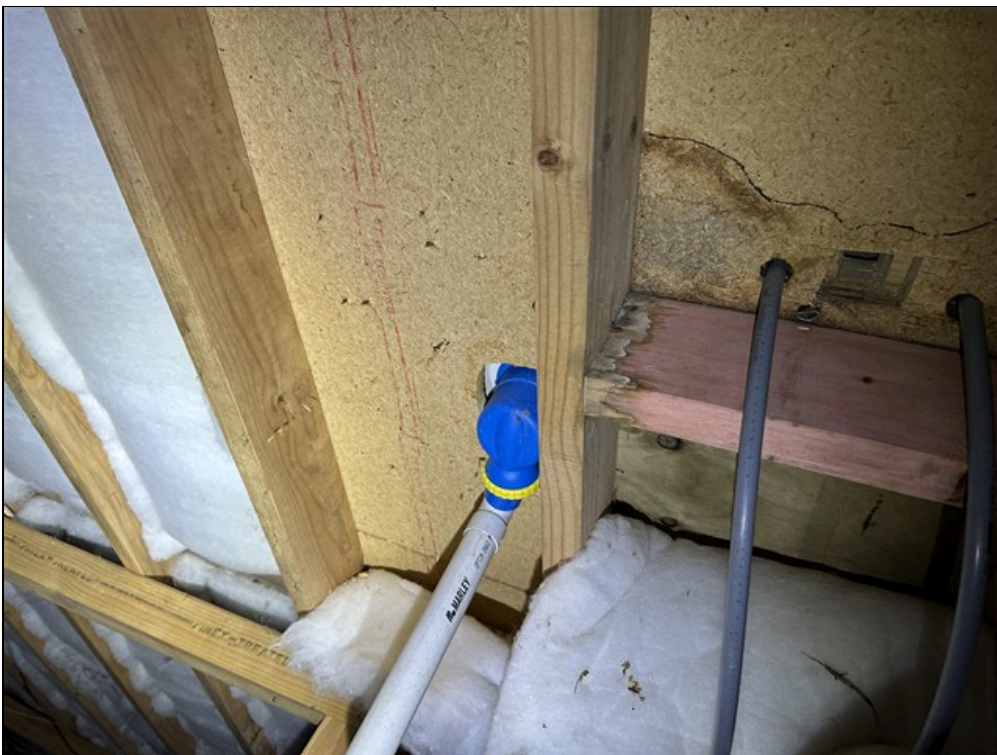
5.19.F Item 9(Picture) Area Has Been Left Open To Ensure It Completely Dries Out

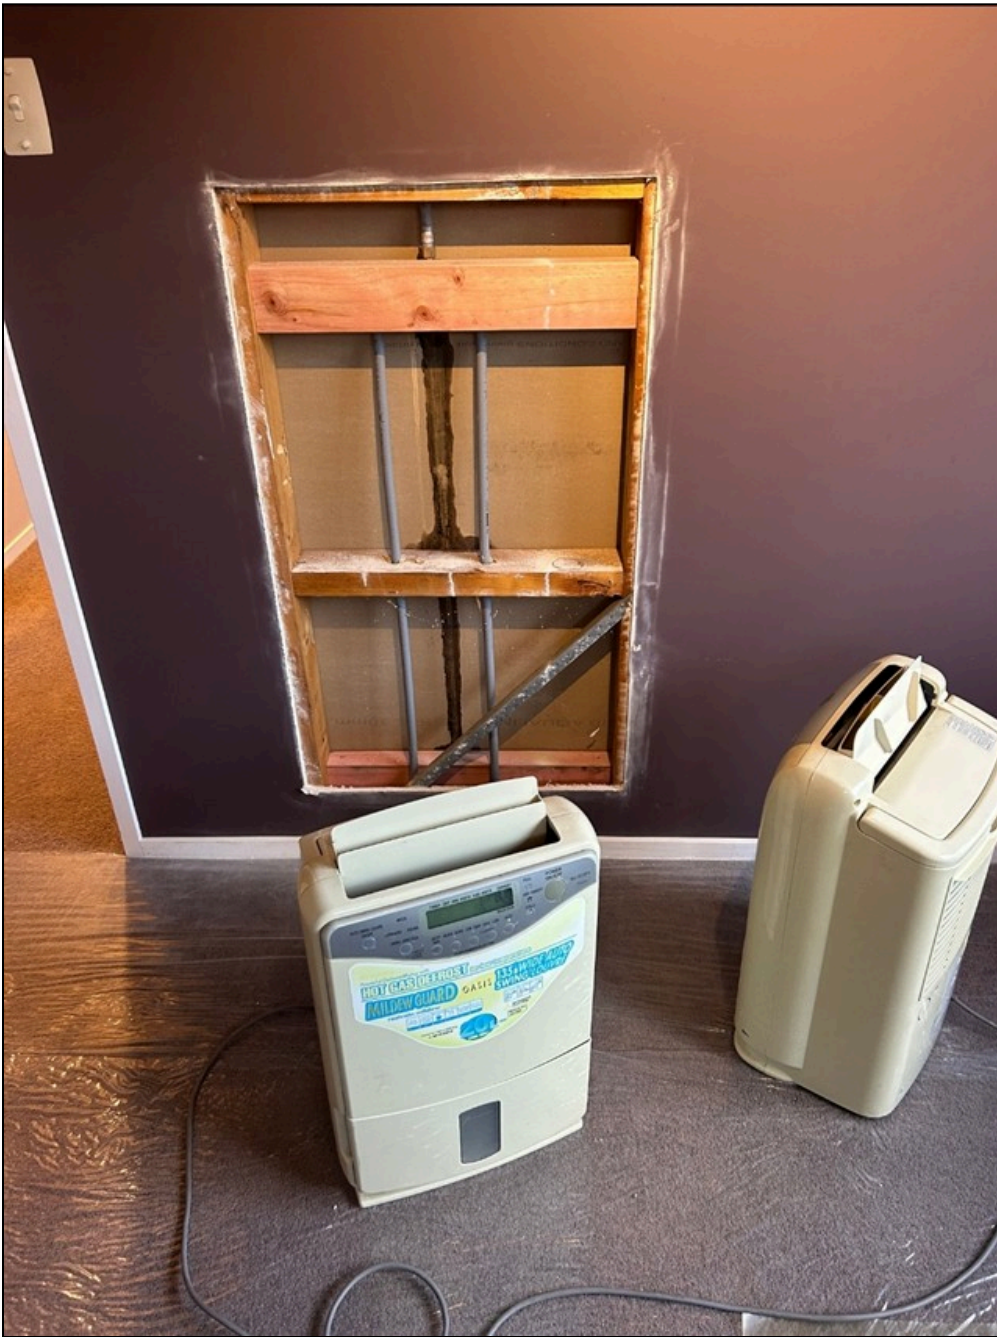
5.19.F Item 10(Picture) Photos Of Wall Opened Up (Supplied By Owner)

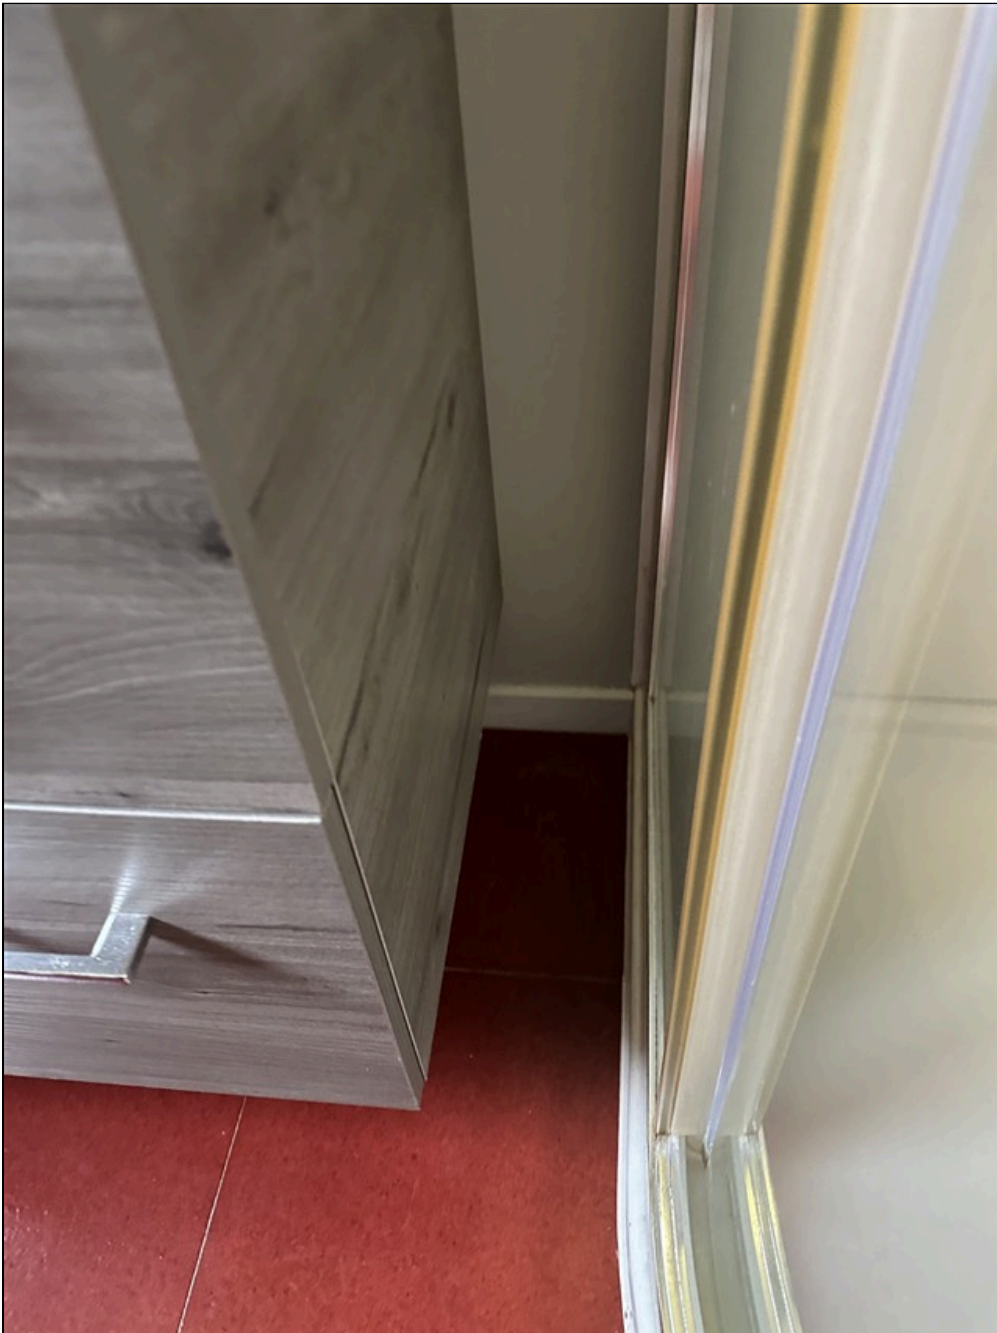
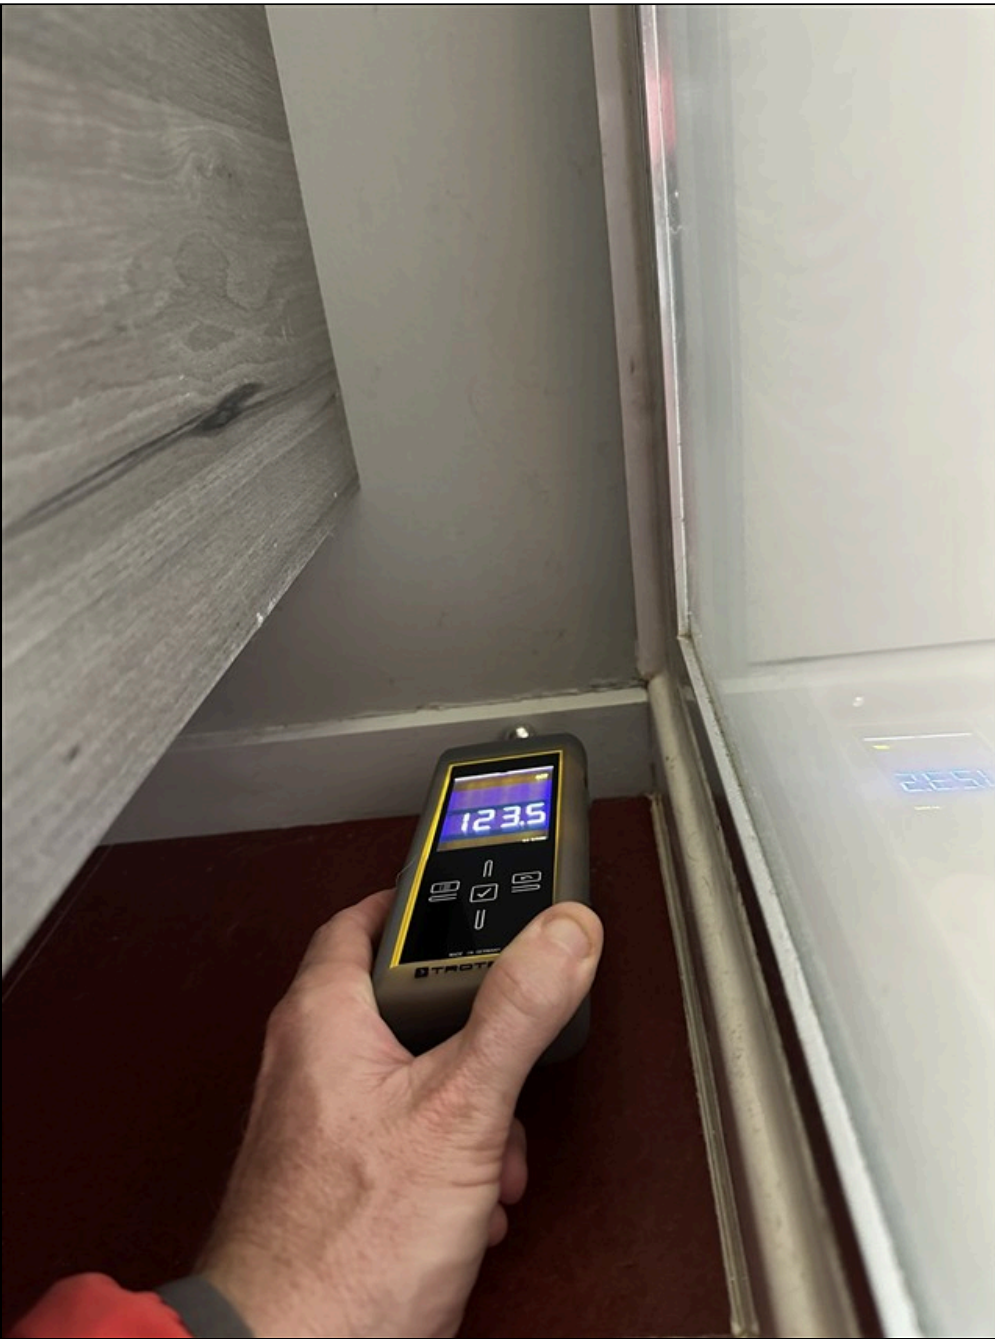
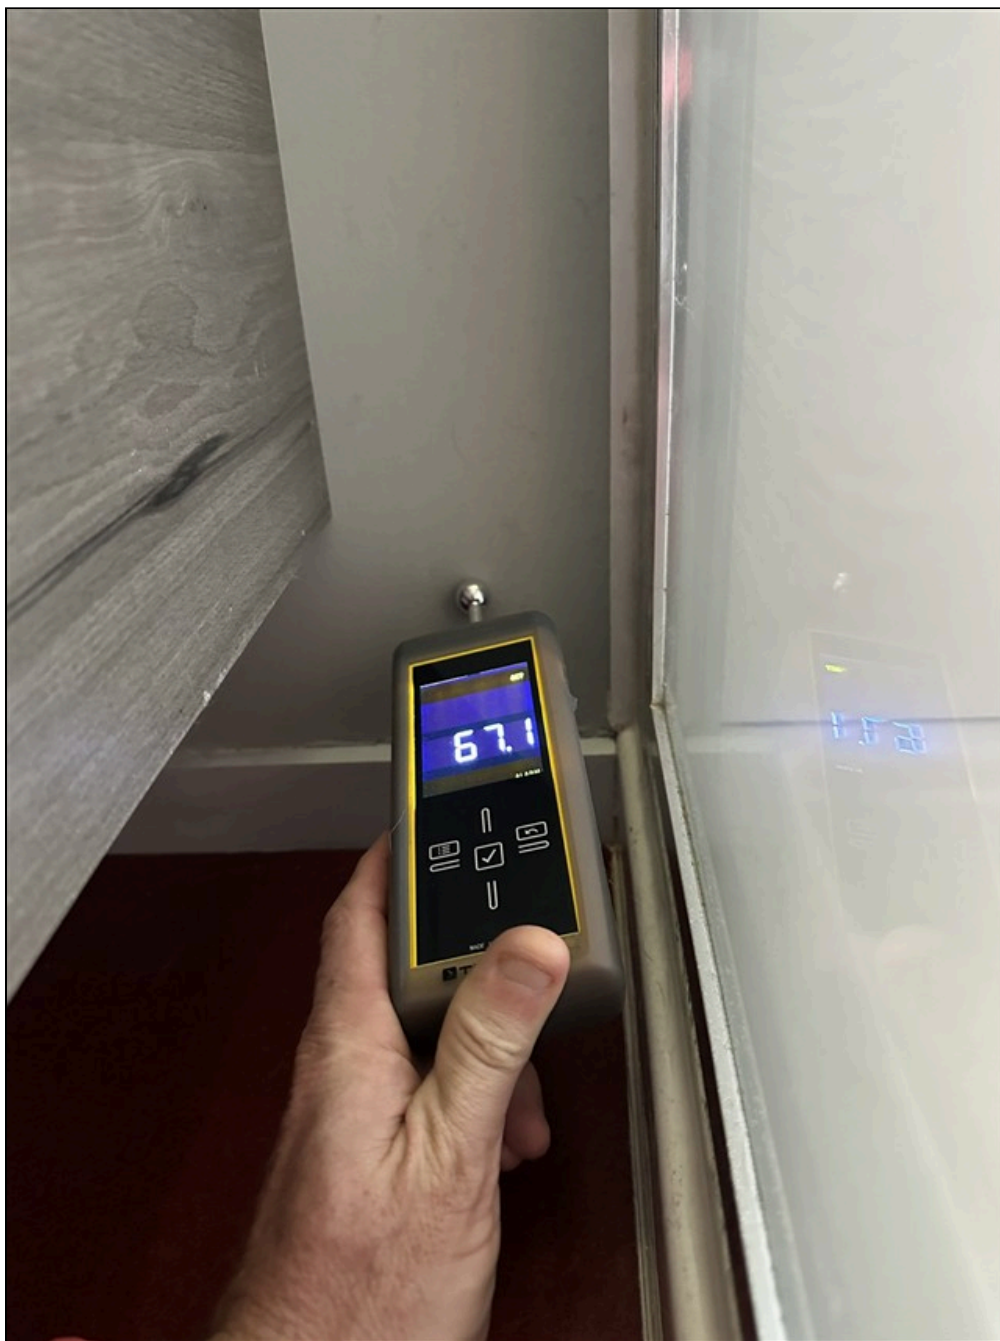
the shower unit installed in the Bathroom. These elevated levels were detected to the bottom of the wall only. A possible cause of these levels could be from a small amount of moisture coming through from the bottom inside corner of the shower. We are however not able to totally rule out that the moisture isn't left behind from the previous faceplate leak as identified in section 5.19(2) in this report. There were no elevated levels identified to the opposite side of the wall in Bedroom One wall, which suggests that this is a smaller leak exposed to the plasterboard mainly. There were also no indications of moisture identified to this area underneath the house. We recommend that this corner of the shower is further sealed to ensure that this area is as watertight as possible.

Please note that wet on the moisture meter doesn't necessarily mean that the area being tested is physically wet to touch and see and is in relation to what a dry wall/timber should be. For a dry area we would see levels under 40 digits, damp range being between 40-80 digits and wet range over 80 digits.

5.19.F Item 12(Picture) Bathroom Wall To The Left Of The Shower Unit

5.19.F Item 13(Picture) Some Signs Of Moisture In The Skirting Next To The Shower Unit

5.19.F Item 14(Picture) Some Signs Of Moisture In The Plasterboard Next To The Shower Unit
