# LAND INFORMATION MEMORANDUM

**Property Address:** 32 Aberfoyle Street Hamilton

**Project:** Timber Pole Retaining Wall – No.32 Aberfoyle Street, Hamilton

**Re: Site Investigation and Remedial Works Recommendations  
Failed Retaining Wall at Access to No. 32 Aberfoyle Street, Hamilton**

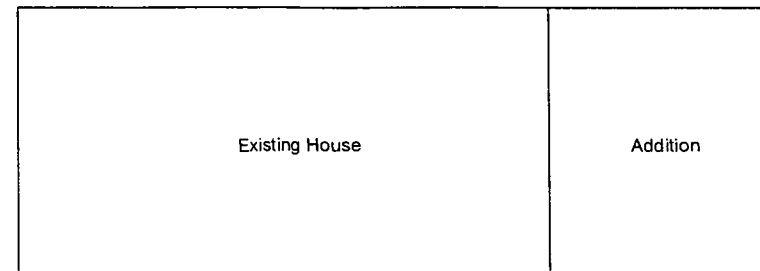
DRAWING No. 8366-01  
DATE October 2007  
ISSUE One

The location of the retaining wall is shown on the attached Site Plan Drawing No. 8366-01.

The alignment of the sewer pipe is also uncertain. We have been able to locate one manhole (R15 034), but the downstream manhole (R15 044) is buried and could not be located. The pipe alignment shown on the Plan drawing is therefore based on sighting the line of the pipe from the known manhole. However it is noted that this alignment differs slightly from the Hamilton City Council As-Built records.
