Geotechnical Retrospective Investigative Report

Project Address: 23 Holloway Place, Forest Lake, Hamilton

Reference: 34807103

Date: 7-Jul-25

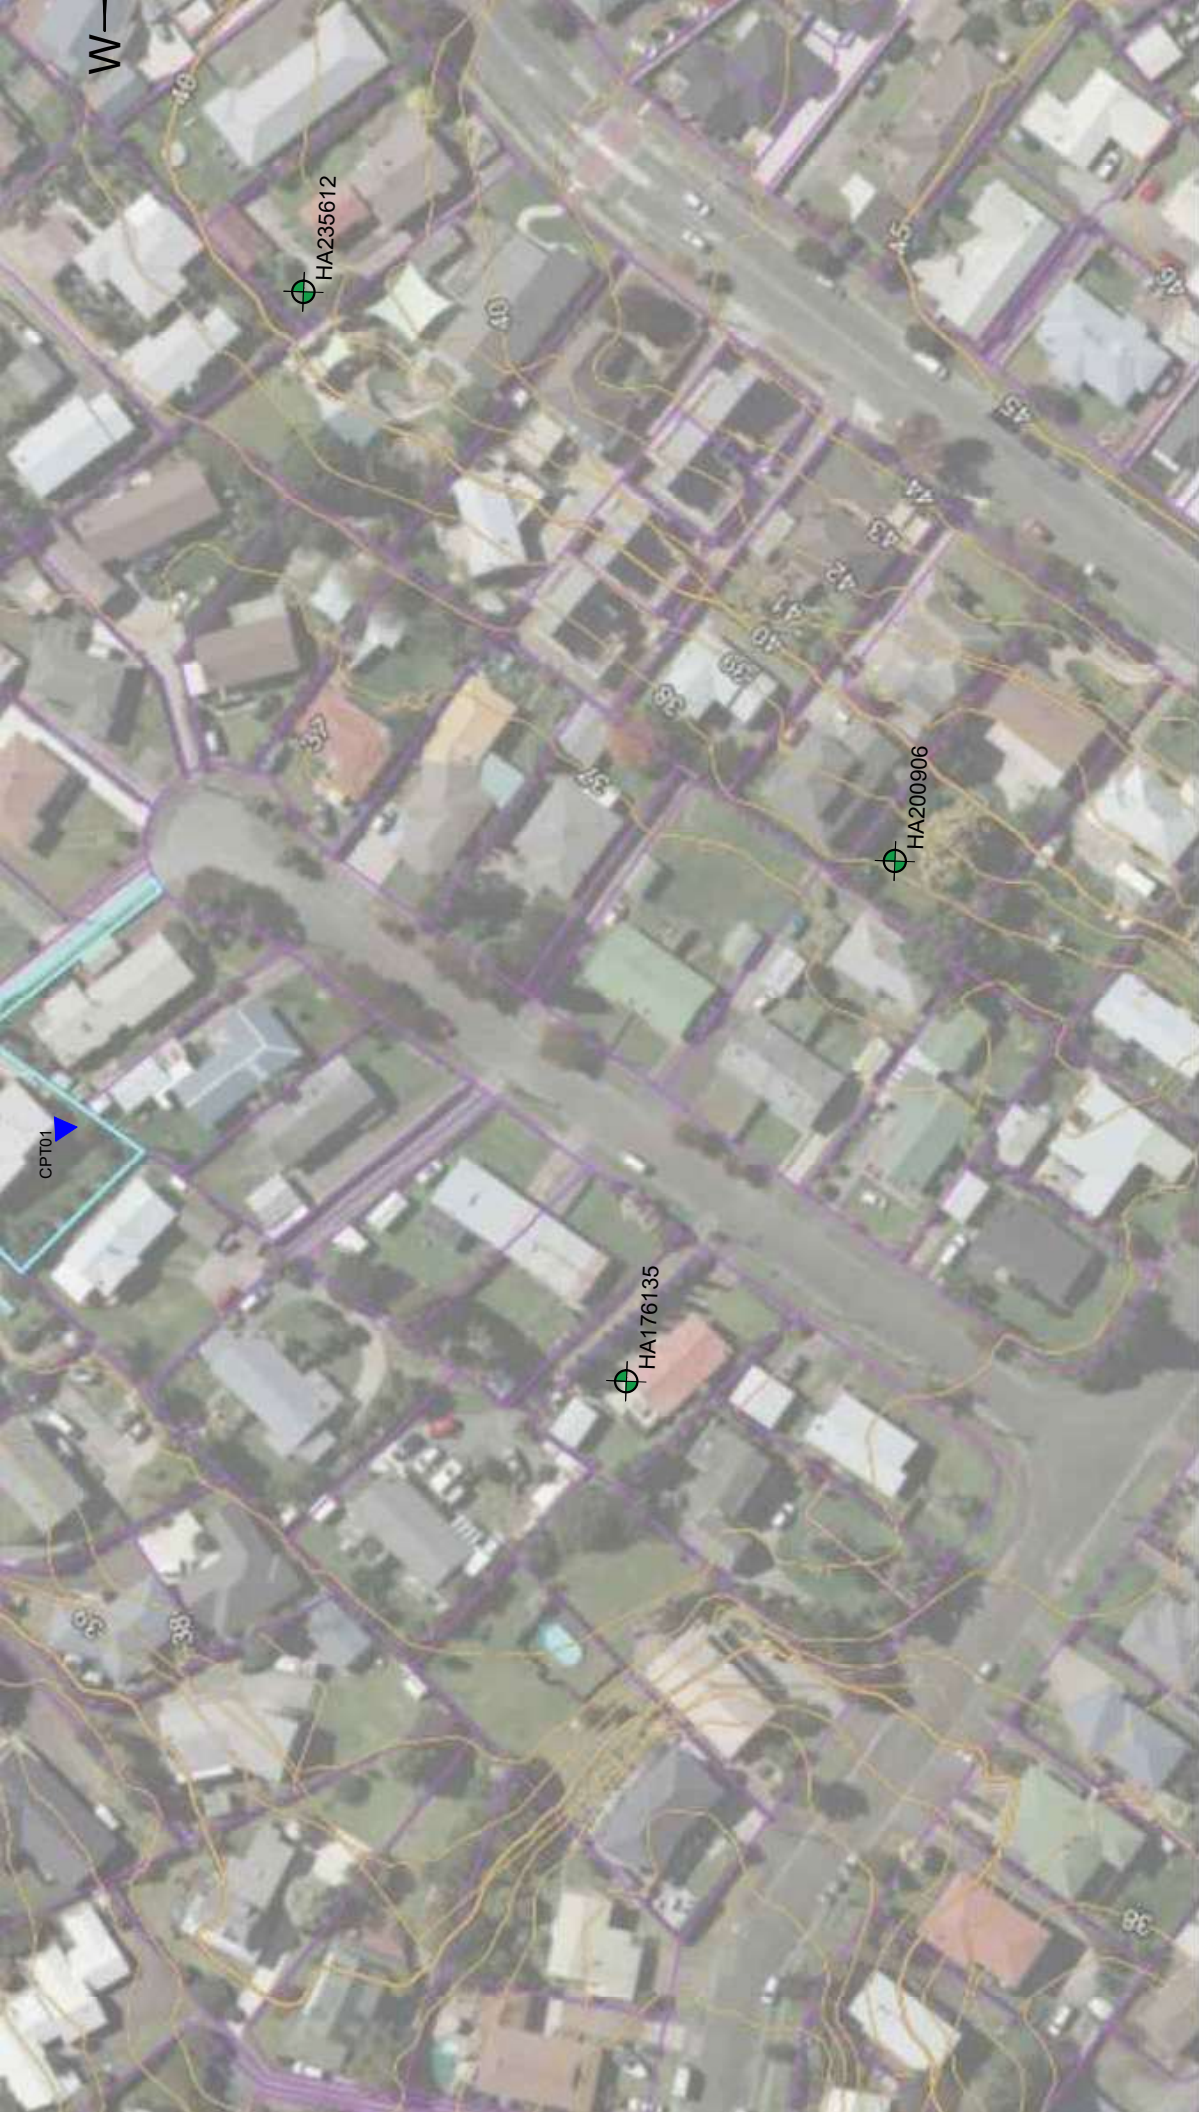
TECHNICAL DATABASE OBTAINED HAND AUGER BOREHOLE POSITION

The location of the above test is shown in **Drawing 07-01**. The previous investigations obtained from NZGD at HA149524 & HA176135 coincide with the thickness of peat and sand below the peat that we found with our CPT investigation on this property.

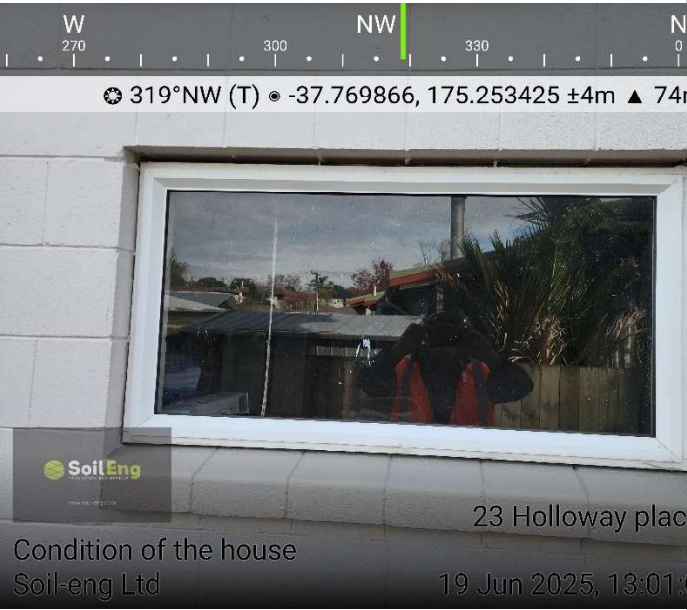
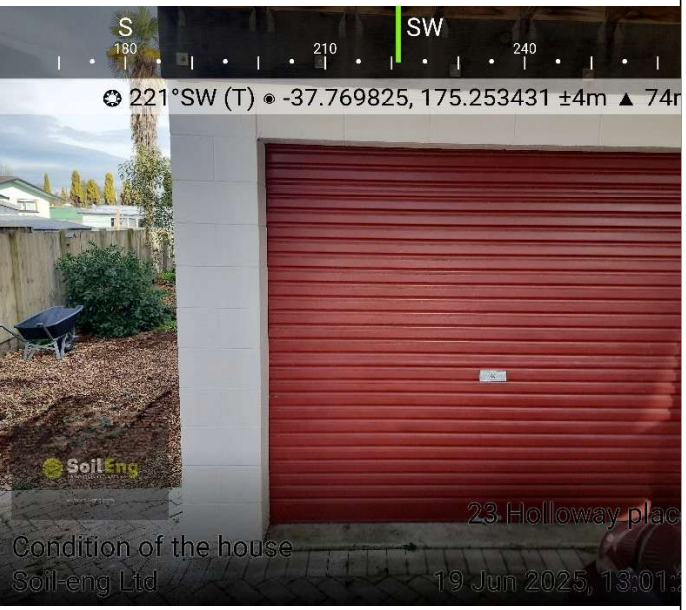
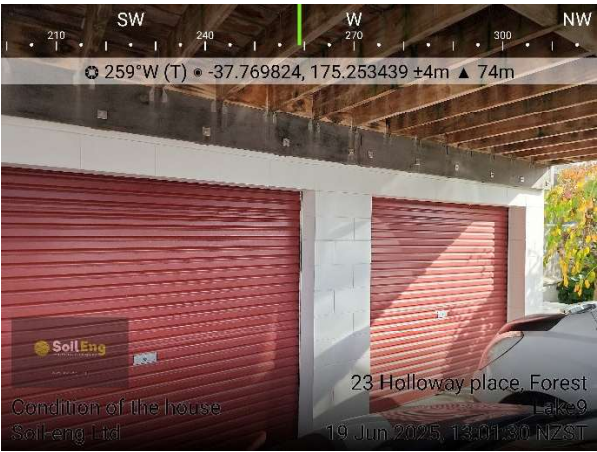
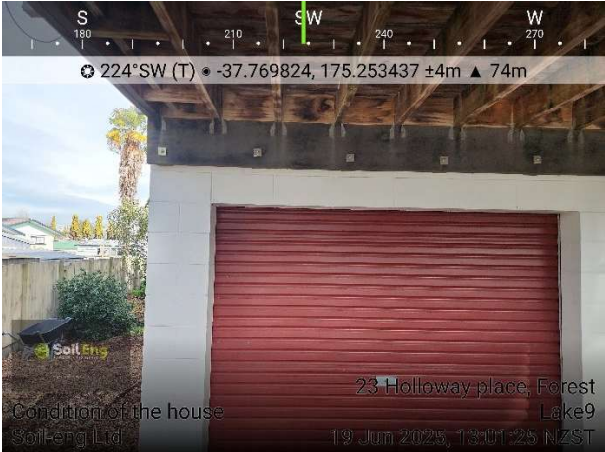
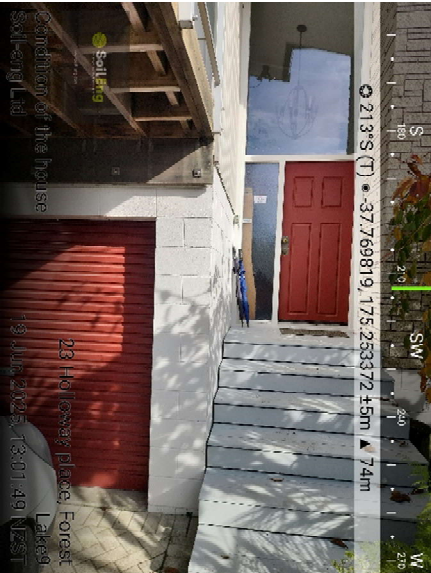
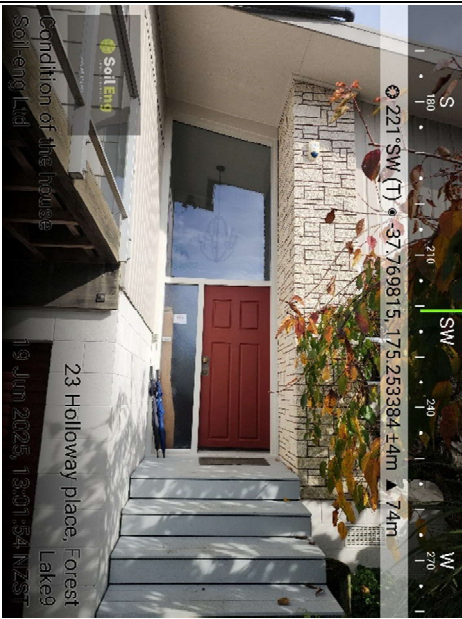
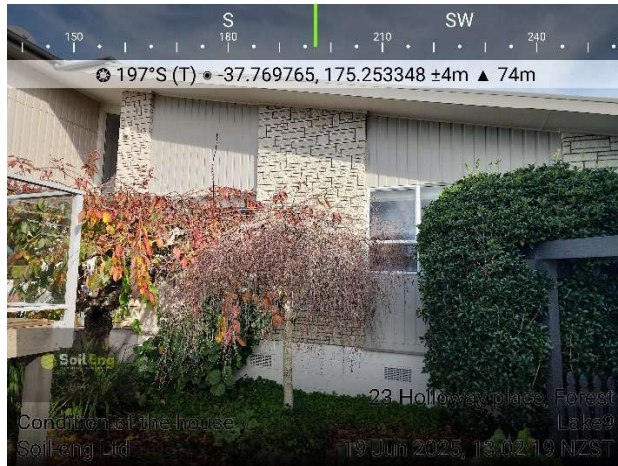
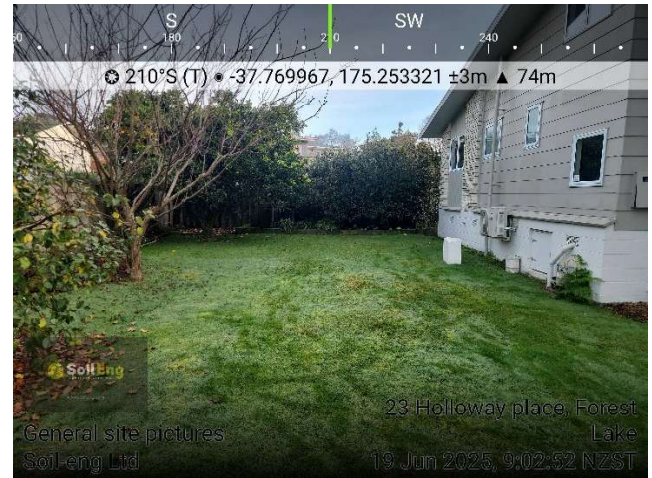
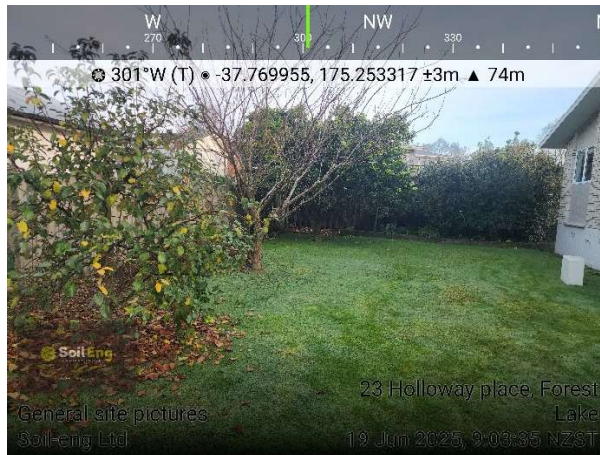
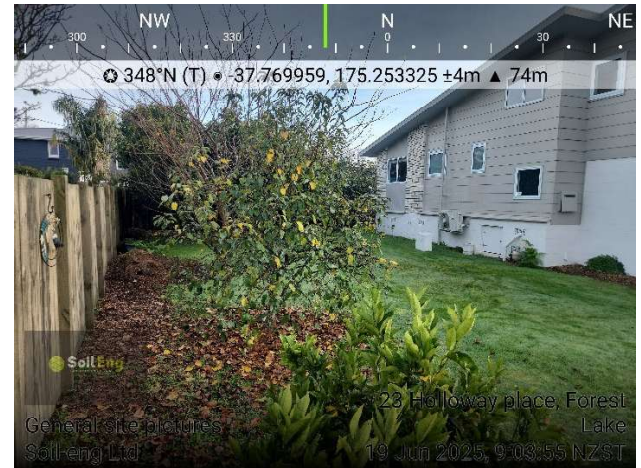
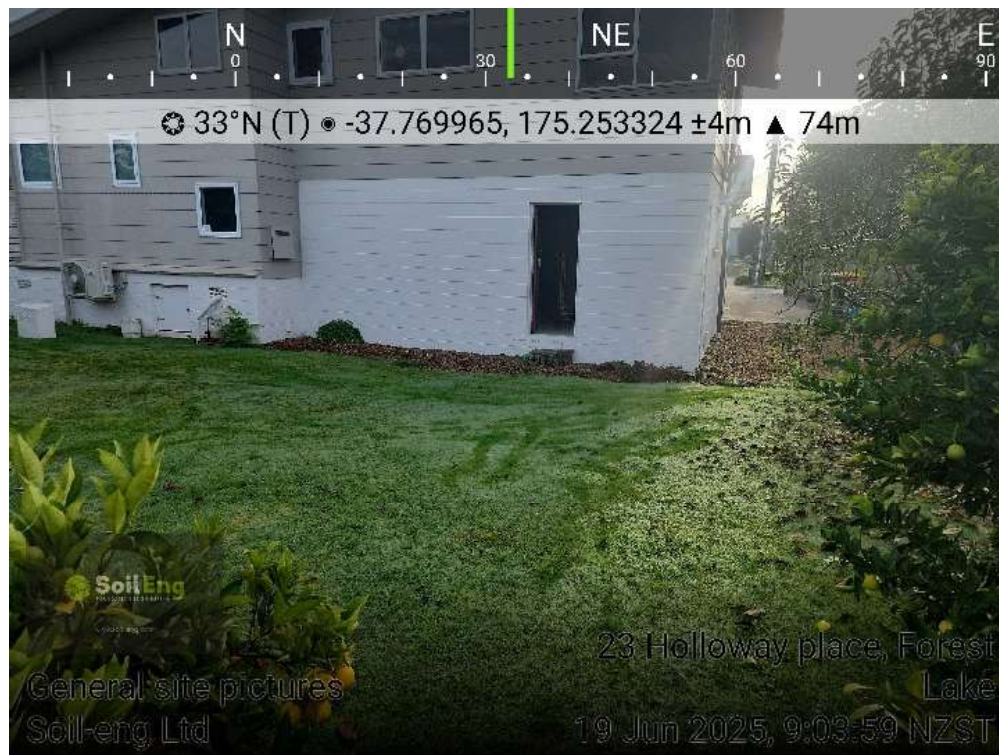
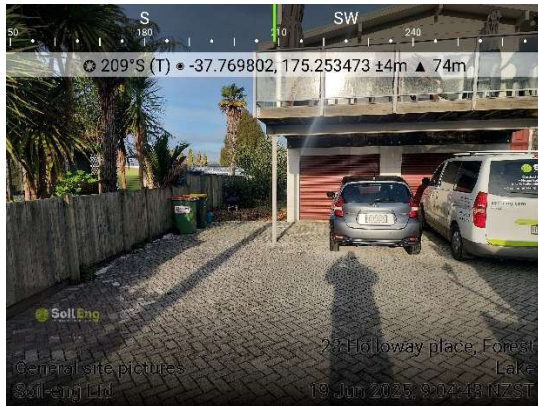
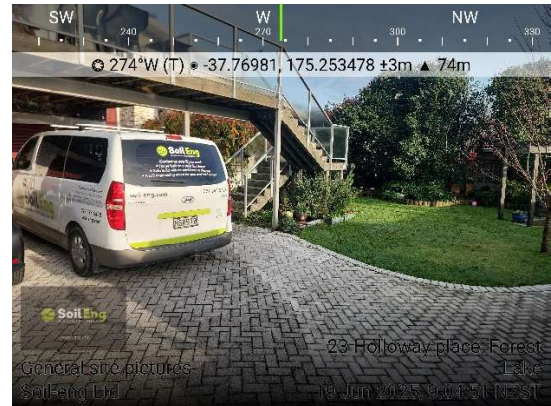
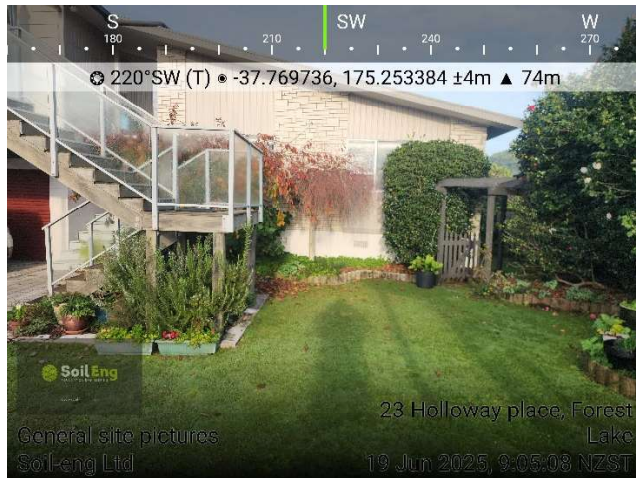
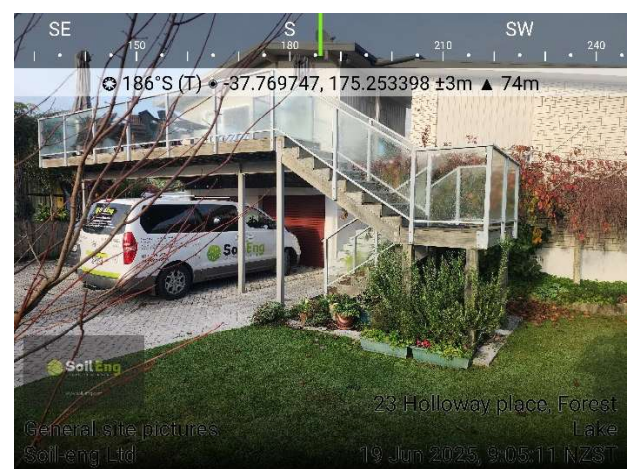
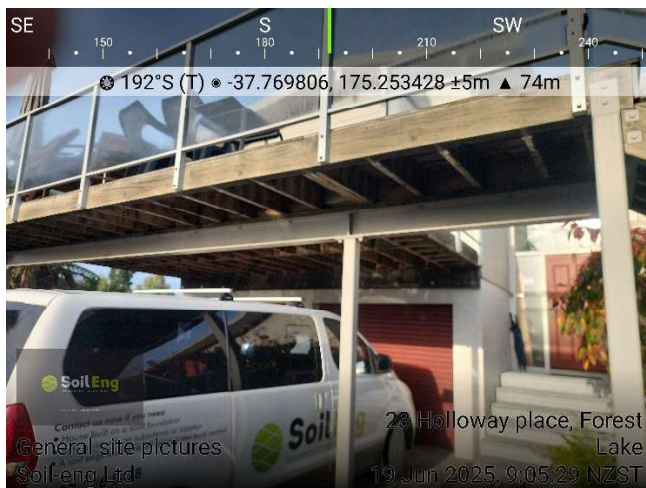
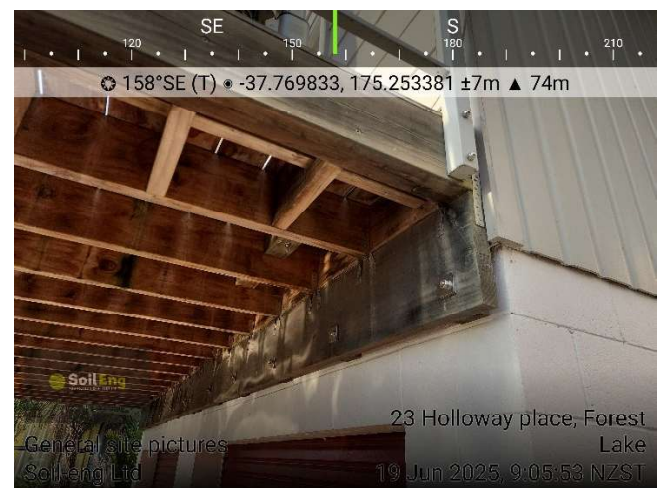
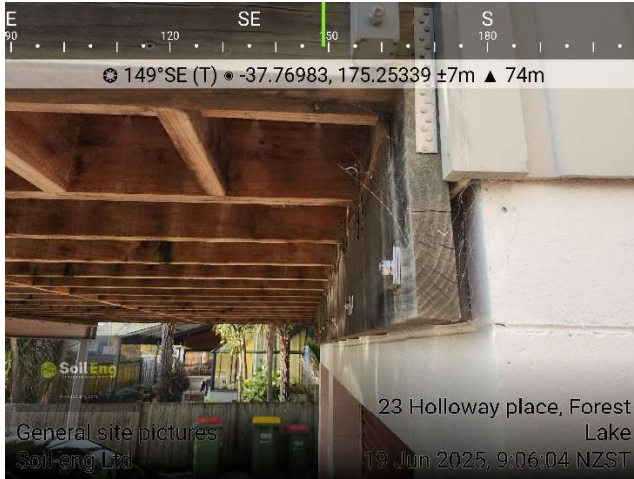
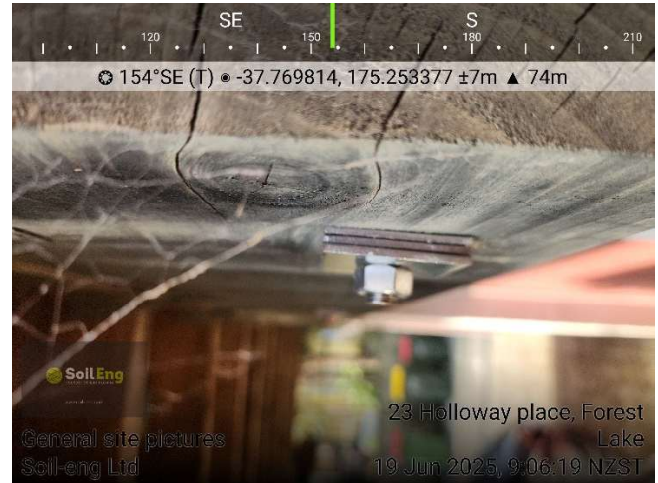
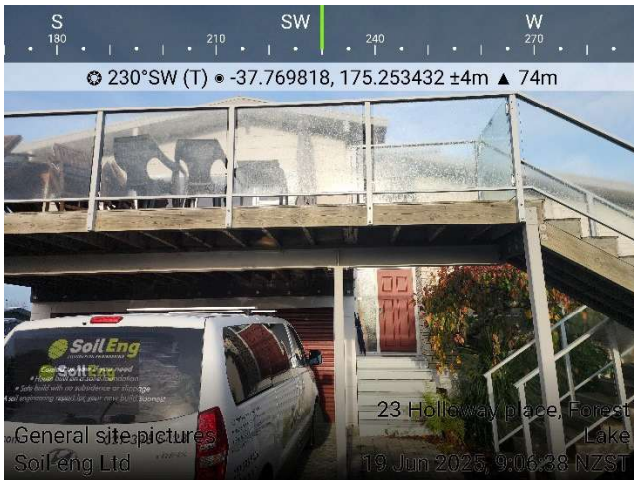
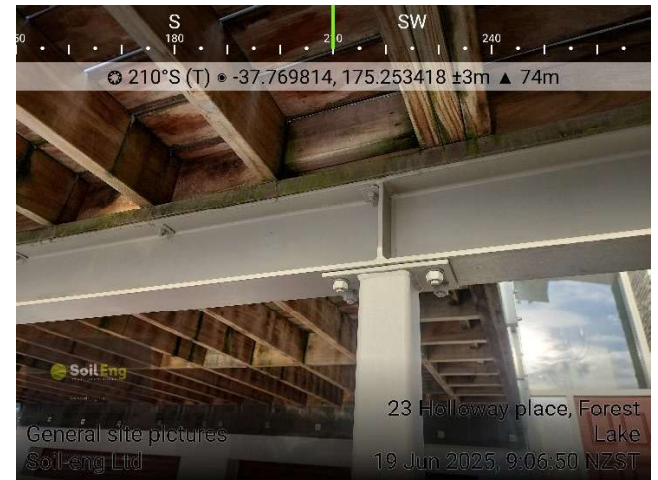
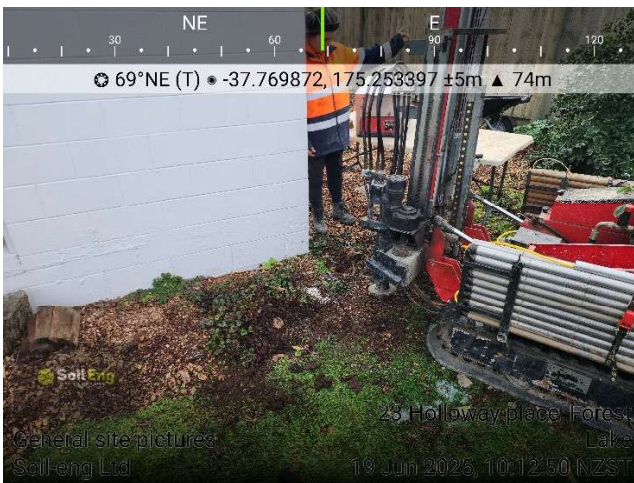
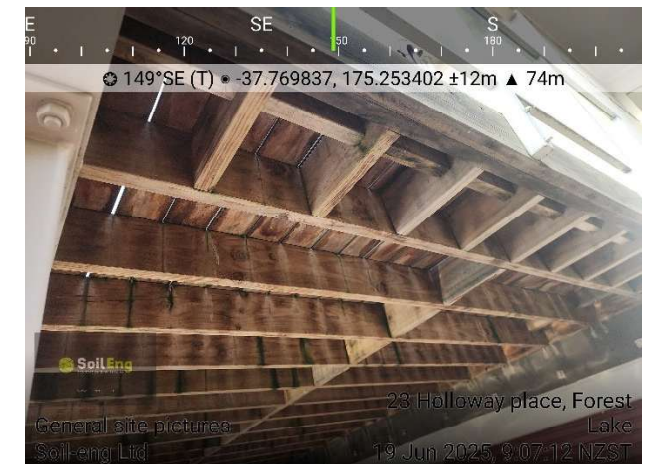
General Site Pictures, in all directions:

To put the above in perspective, the soil that supports the bottom of the piles and the house can provide three times more resistance than what is required. This is further confirmed by our visual inspection of the house exterior and not finding any indications that the house is currently under foundation stress. Also, see our photo file.
