Inspection Report

Property Address:
23 Holloway Place
Hamilton
Pre Sale / Vendors Report .

23 Holloway Place, Hamilton

Total House Inspections

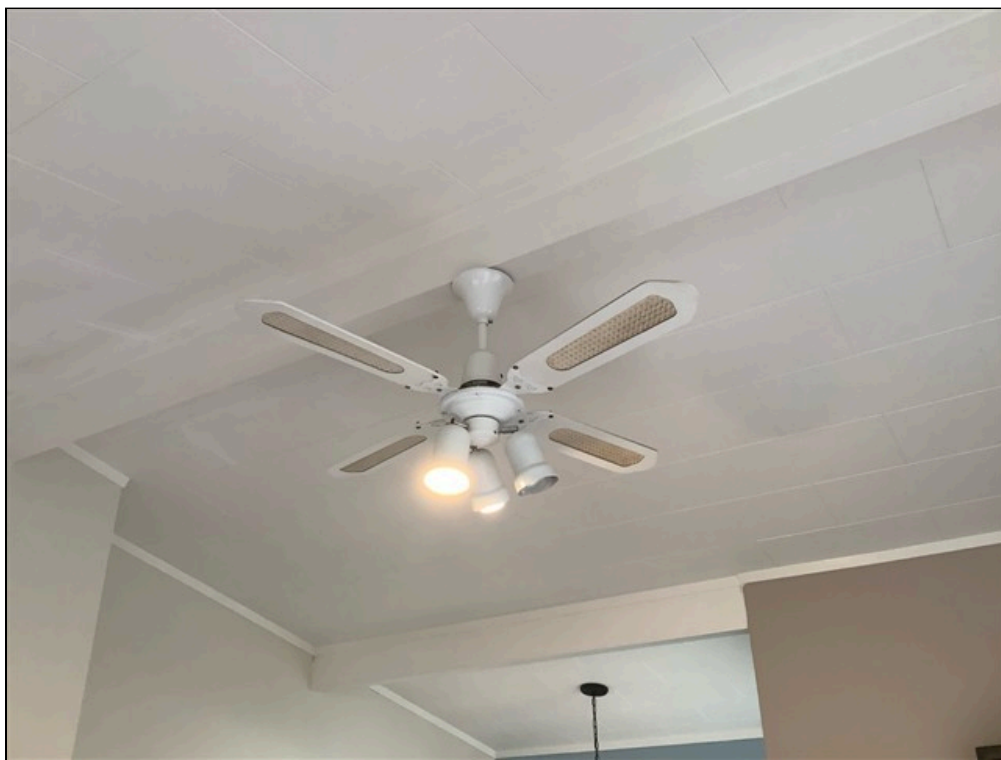
5.8.D There is a Ceiling Fan installed in this room that was tested and working at the time of the inspection.

5.8.D Item 1(Picture) Ceiling Fan Installed In The Living

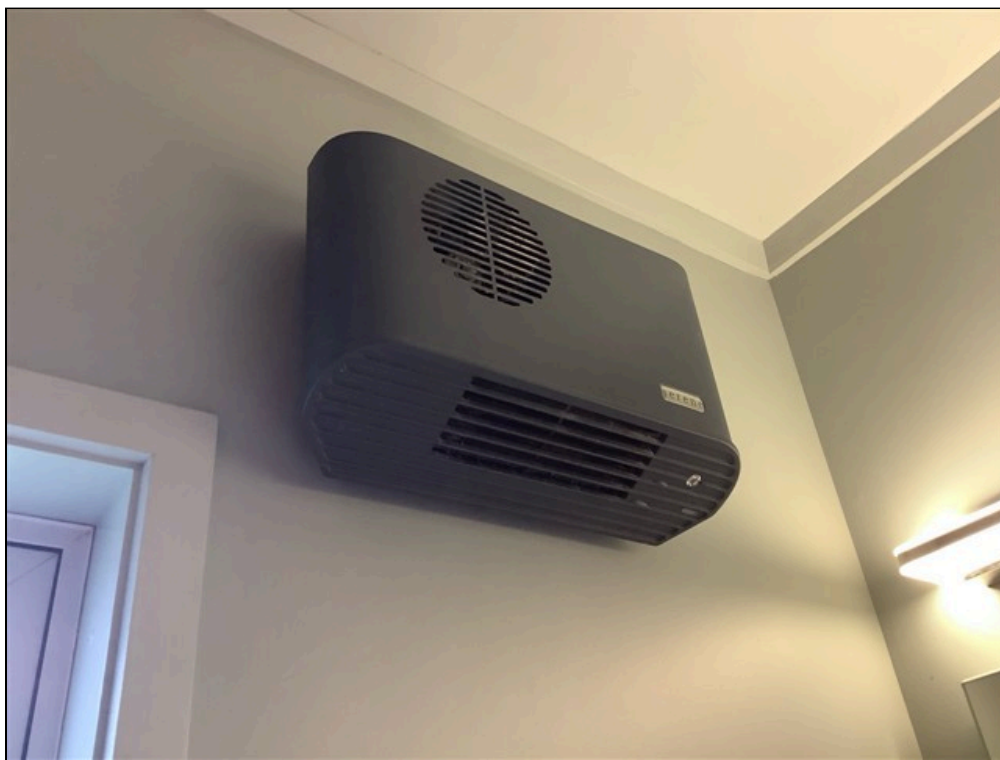
5.8.F There is an Electric Fan Heater installed on the wall of this room. This appliance was not tested as part of the inspection.

5.8.F Item 1(Picture) Electric Fan Installed In The Bathroom

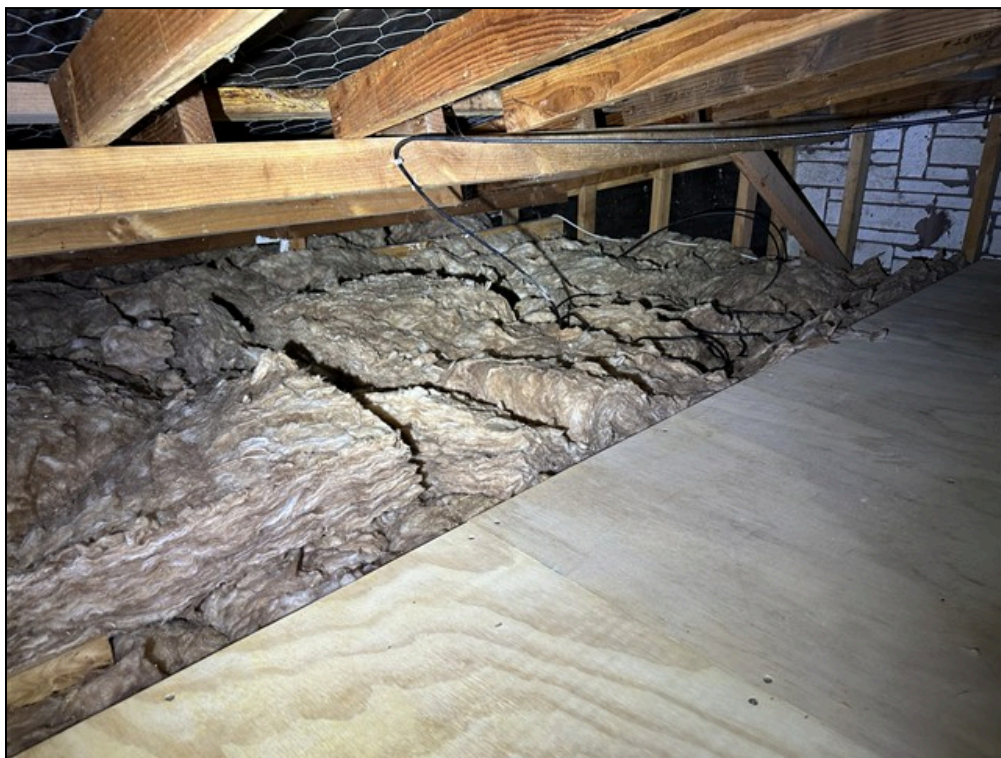
7.3 There is coverage of Earth Wool insulation installed in the Roof Cavity of the house. This insulation is approximately 120 - 150mm thick and it is approximately covering 100% of the total area of the Roof Cavity.

7.3 Item 1(Picture) Earthwool Insulation Installed In The Roof Cavity Area Of The House

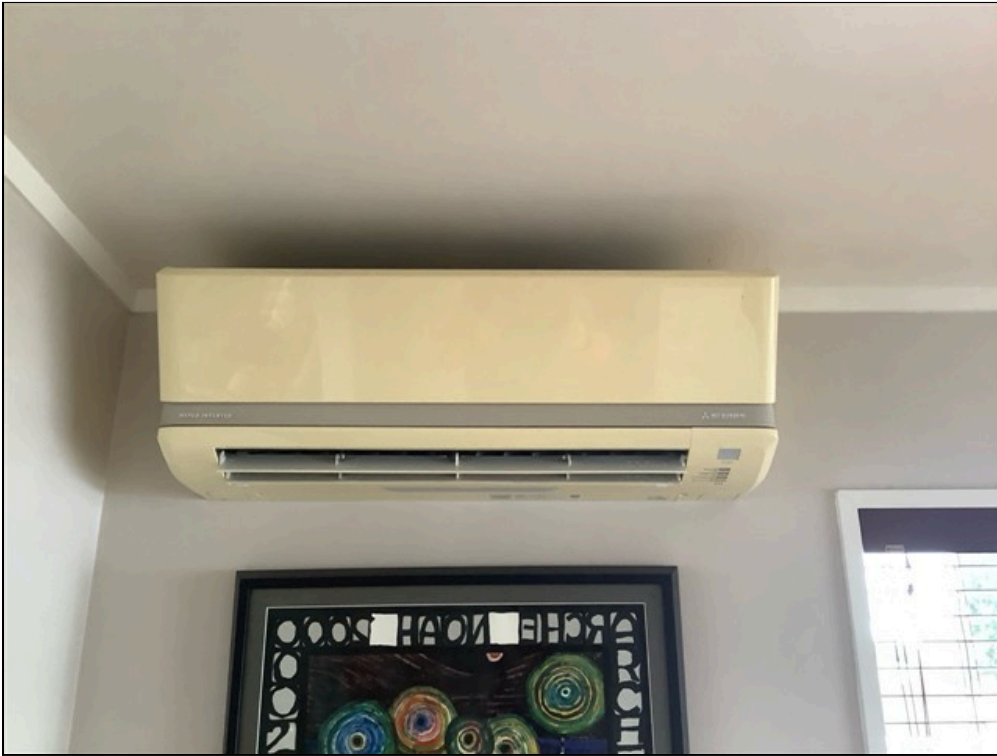
8.2 Item 1(Picture) Heat Pump Installed In The Dining Room

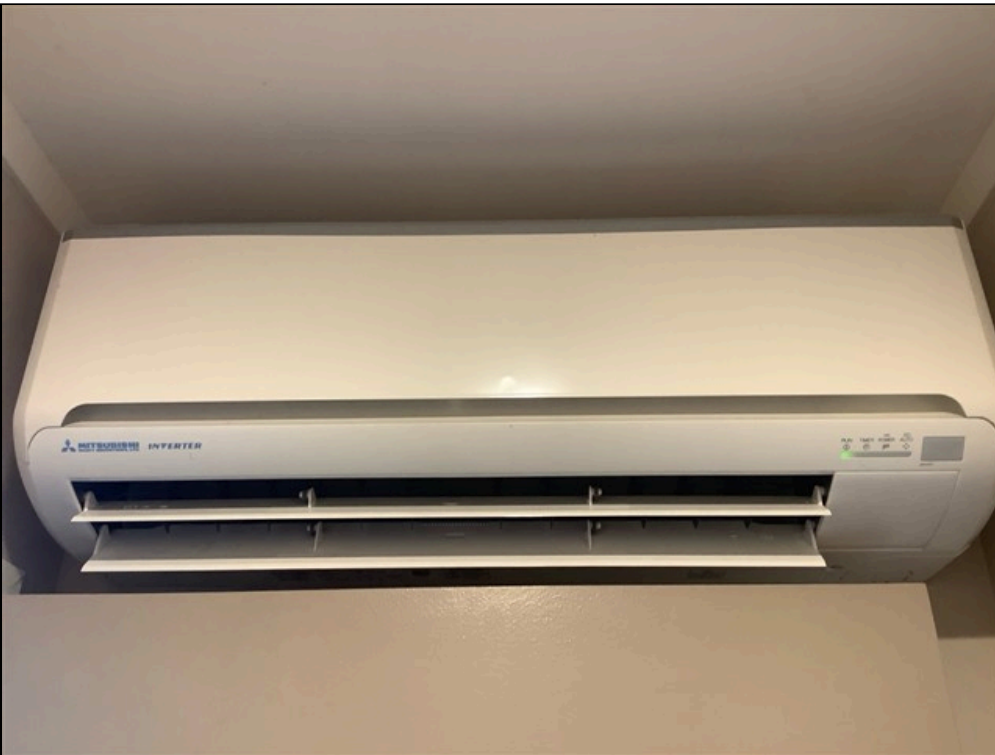
8.2 Item 2(Picture) Heat Pump Installed In The Hallway

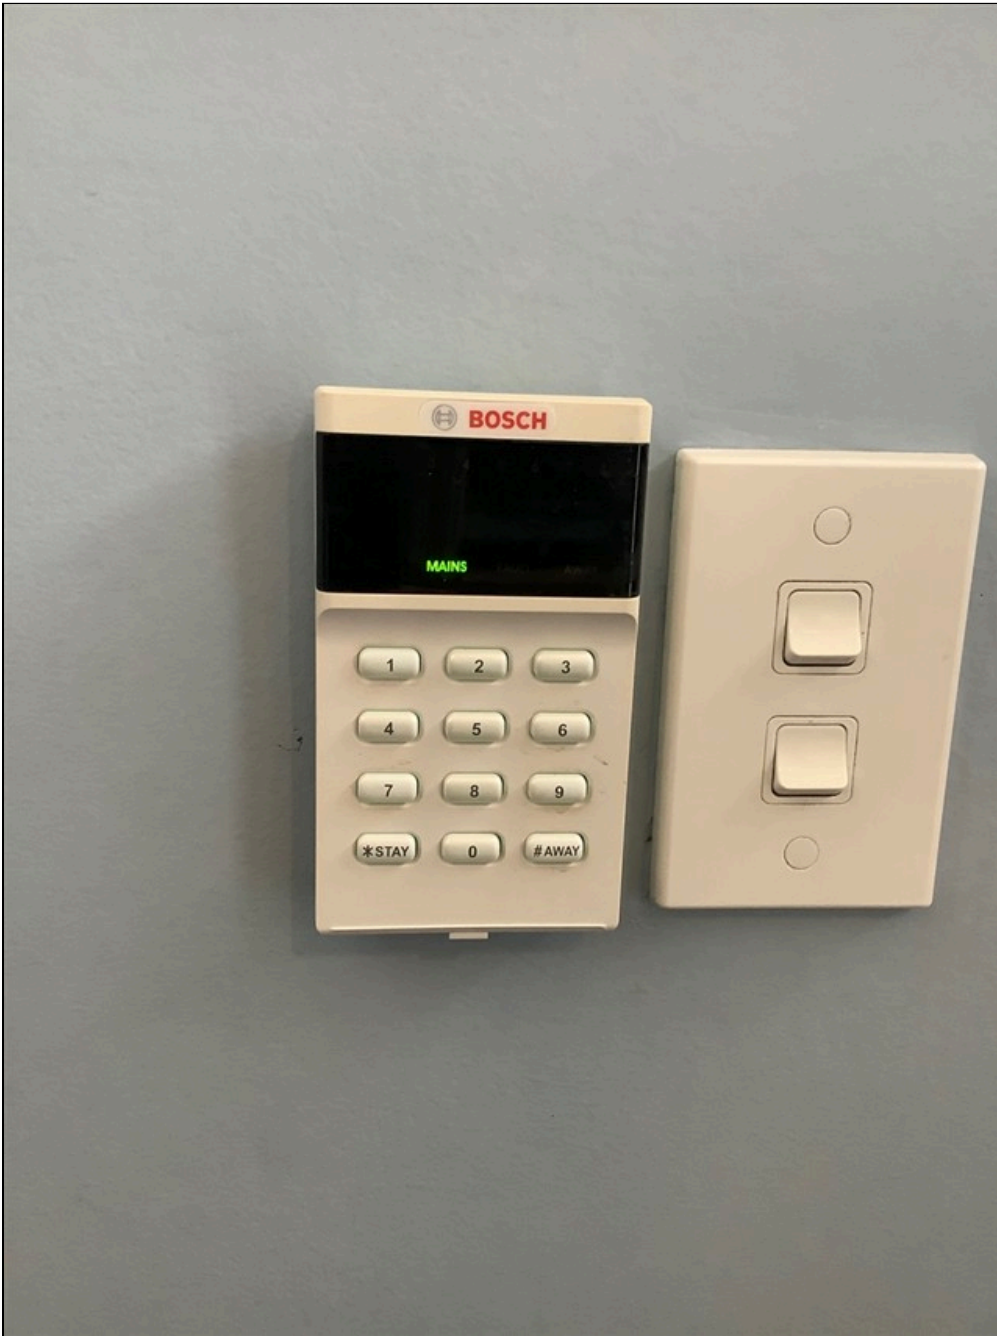
8.5 There is a alarm system installed in the property. The alarm system hub is situated in the Roof Cavity, while the keypad is located on the wall of the Front Entry.

8.5 Item 1(Picture) Keypad For The Alarm Situated On The Wall Of The Front Entry
