TRANSFERRABLE PRE-SALE INSPECTION REPORT

6c & 6d Edgecumbe Street, Whitiara, Hamilton, 3200

Date of Inspection: 4/11/2025 Time: 12:00 PM

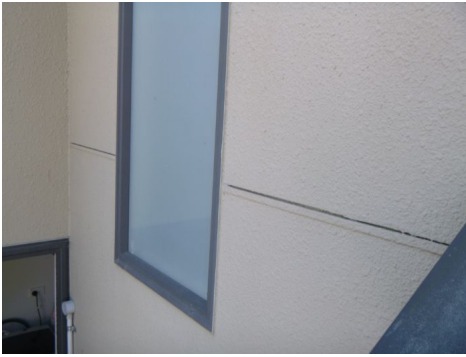
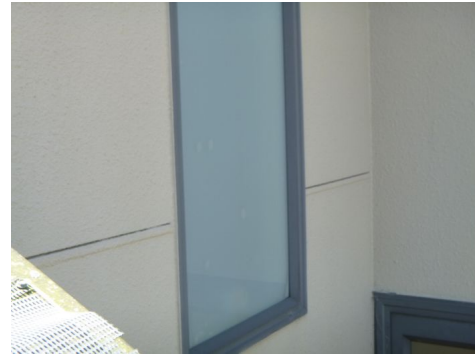
- Present not only on all doors and windows but also between levels of the house.

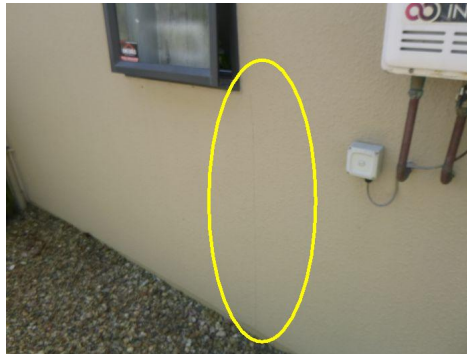
Rear of 6c

- A lot of cracks present and all appear to be near joinery. All cracks are minor (thin and vertical). This is not uncommon for a building this age. They may only require painting with an elastomeric paint without the need for sealant however I recommend consulting a cladding/painting professional to confirm.

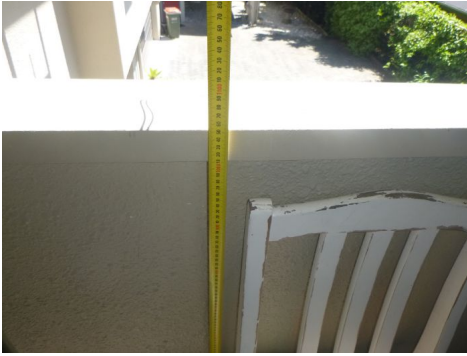
6c >1000mm high

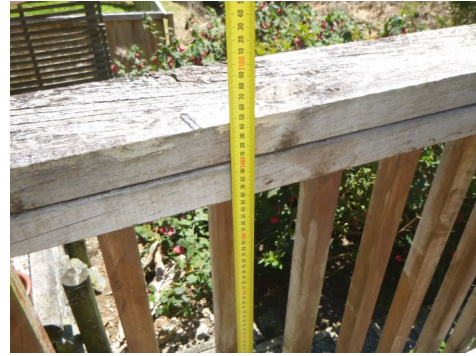
6d > 1000mm

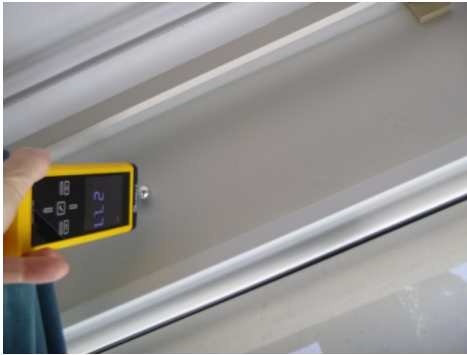
6c downstairs

M D NI
X • Several readings were taken and most were within the acceptable range and indicate most of the bedrooms to be DRY.
• Readings taken on a section of wall underneath the window in the downstairs bedroom of 6c were within the higher range and indicate this part of the room to be WET. There is no other indication of moisture ingress - no swelling, no odours, no staining, no warping. The cladding outside the window appears in satisfactory condition. It could be an older issue that has since been resolved?

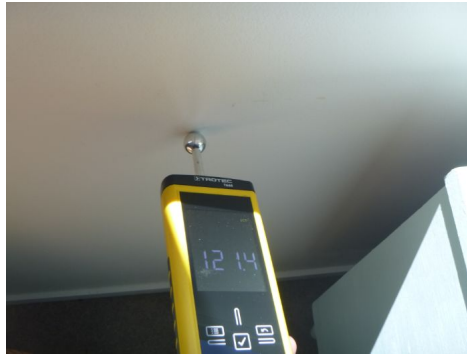
6c downstairs HIGH reading

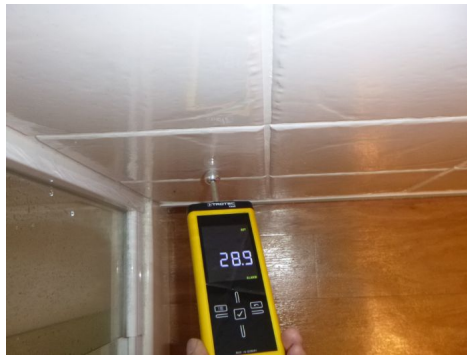
- M D NI • Several readings were taken and all were within the acceptable range and indicate the bathrooms to be DRY (typical common values are over 40 digits on the T660 moisture meter for tiled bathrooms)

6c upstairs beside shower

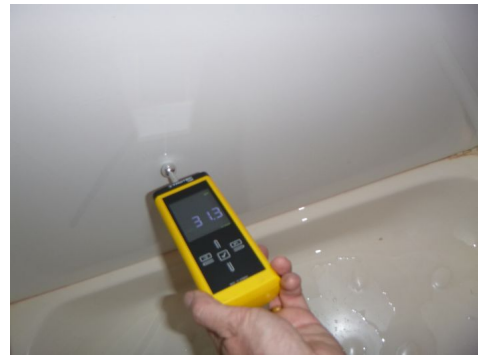
6c upstairs within shower

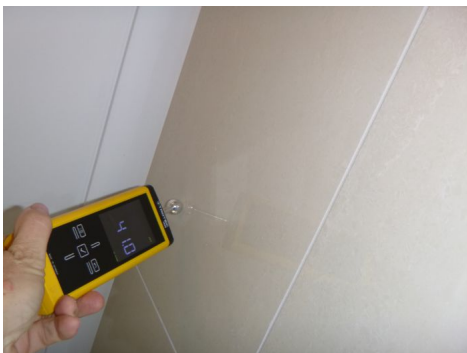
6c downstairs (baseline)

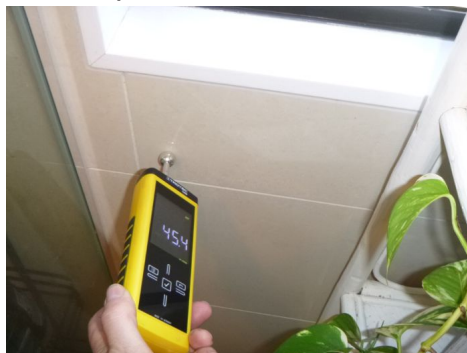
6c downstairs

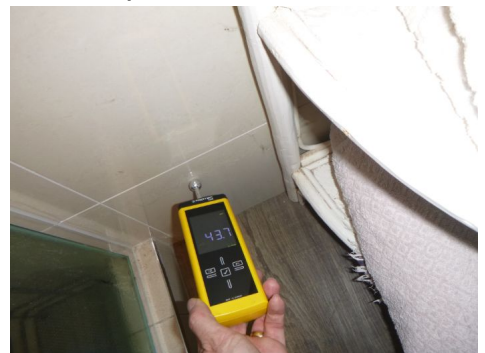
6c downstairs beside shower

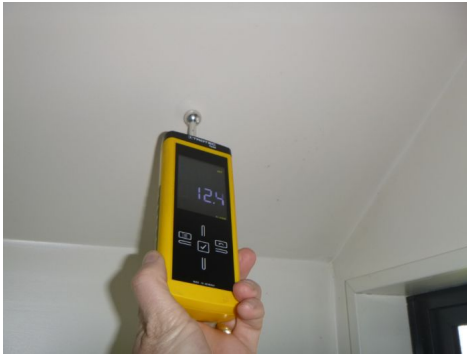
6d upstairs

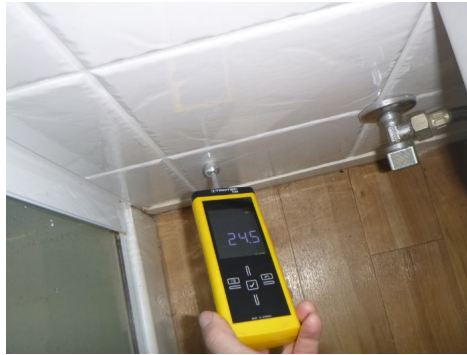
6d upstairs beside shower

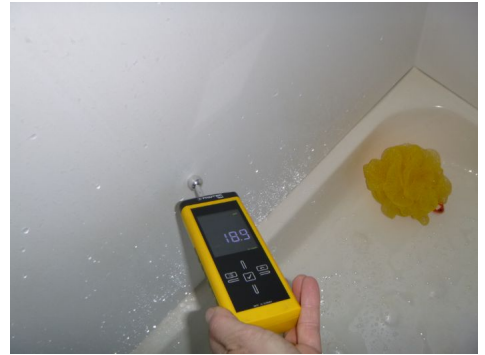
6d upstairs within shower

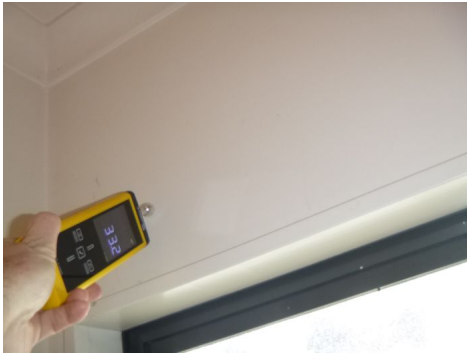
6d downstairs

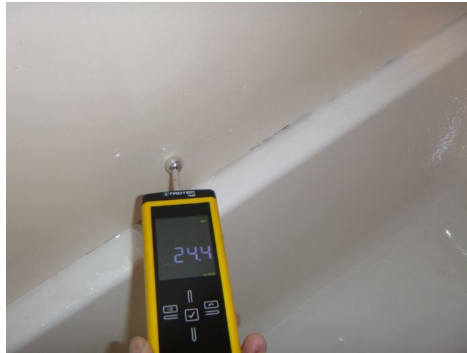
6d downstairs beside shower/bath

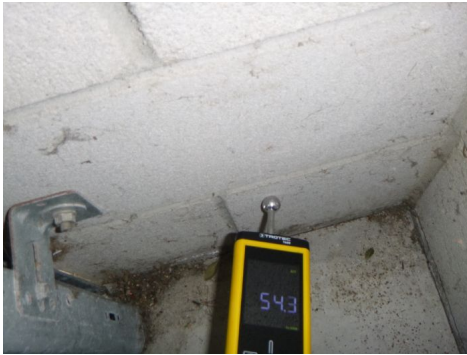
M D NI • A number of moisture readings were taken within this room all found to be of an acceptable level. Typical common values are over 100 on the T660 moisture meter for bare or exposed concrete.

6c beside door

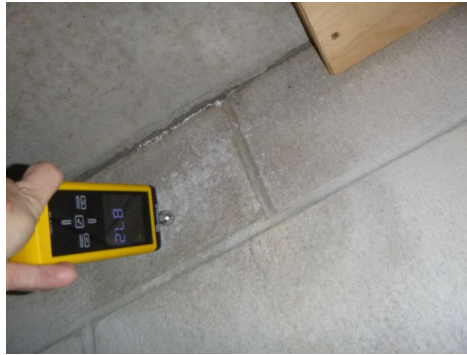
6c rear of garage

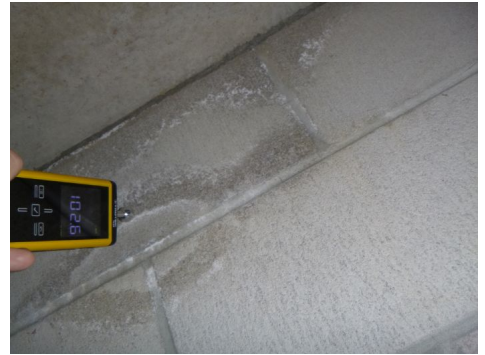
6c rear of garage

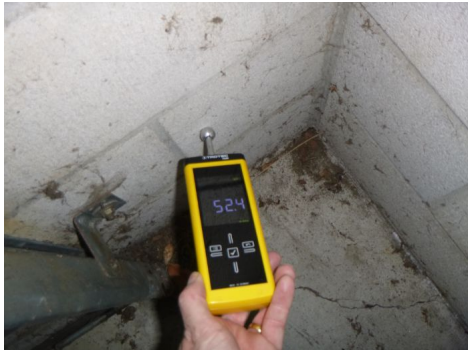
6d beside garage door

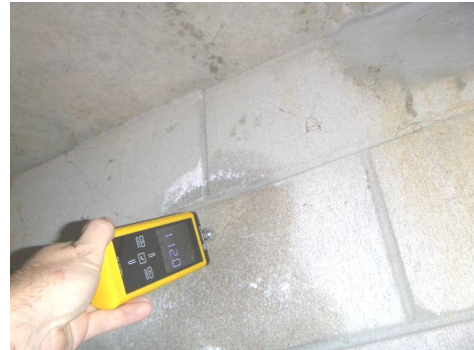
6d rear of garage
